General Information

Make	Toyota	Model	Vios
YOM	2022	Odo Meter Reading	42,907
Registration No.	NES1777	Chassis No.	PA1B18F3M4163627
CC	1.3	Transmission	CVT
Fuel Type	Gas	Type of Body	Sedan
Colour	Red Mica Metallic

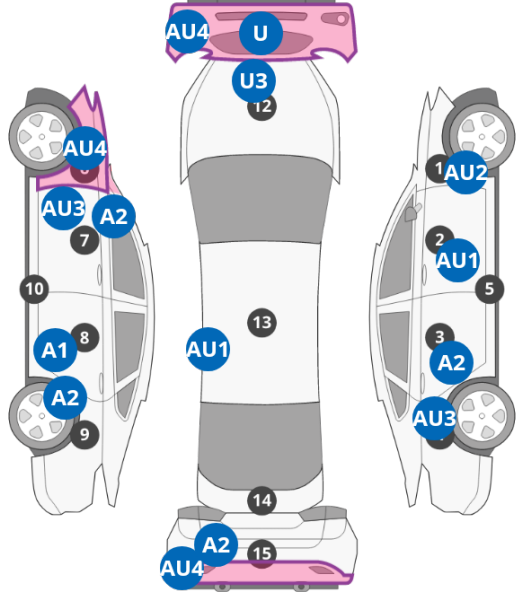
<p>A : Scratch AU : Scratch & Dent B : Modified C : Corrosion G : Stone chip P : Faded S : Rust SC : Rust & Corrosion U : Dent X : Defective Y : Crack, Gap</p>
<p>Remarks Ceiling - Grime - Small / (R) Front Trim - Grime - Small / (R) Front Floor Mat - Grime - Small / Dashboard - Traces of Adhesive Tape - Yes / Overall Interior - Smell - Yes / (L) Front Trim - Grime - Small / (L) Front Floor Mat - Worked - Small / Mat Other - Grime - Small</p>	<p>Remarks (L) Front Fender - Repair Traces - Yes / Trunk Hood, Rear Gate - Repair Traces - Yes / (L) Front Fender, Molding - Repair mark - Yes / (L) Front Fender, Molding - Scratch & Dent - Large / (L) Mirror - Scratch - Small / (L) Front Door, Molding - Scratch & Dent - Medium / (L) Rear Door, Molding - Scratch - Minimal / (L) Rear Fender, Molding - Scratch - Small / Front Bumper, Grille, Lamps - Scratch & Dent - Large / Bonnet, Headlight - Dent - Medium / Member (Bolted) - Dent - Yes / (R) Front Fender, Molding - Scratch & Dent - Small / (R) Front Door, Molding - Scratch & Dent - Minimal / (R) Rear Fender, Molding - Scratch & Dent - Medium / (R) Rear Door, Molding - Scratch - Small / Rear Bumper, Lamps, Panels - Repair mark - Yes / Rear Bumper, Lamps, Panels - Scratch & Dent - Large / Trunk Hood, Rear Gate - Scratch - Small / Roof - Scratch & Dent - Minimal / Front Bumper, Grille, Lamps - Repair mark - Yes</p>
