## General Information

| Make | Toyota | Model | Vios |
| YOM | 2018 | Odo Meter Reading | 56,480 |
| Registration No. | DAD4295 | Chassis No. | PA1B13F35J4055678 |

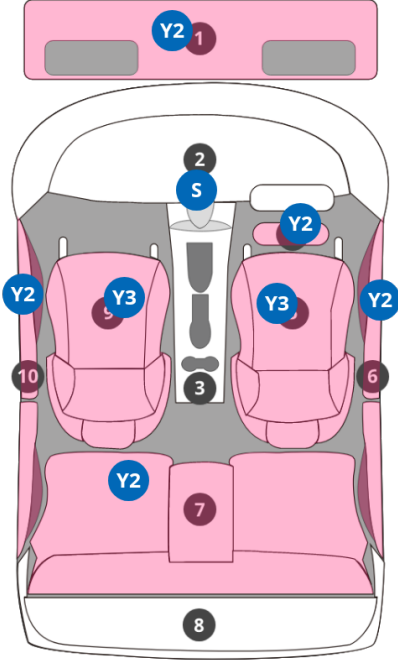
| Interior Evaluation : <b>B</b> | Exterior Evaluation : <b>D</b> |
| <p><b>Remarks</b><br/>(L) Front Seat - Grime - Medium / (L) Front Floor Mat - Grime - Small / Rear Seat - Grime - Small / (R) Front Seat - Grime - Medium / (R) Front Trim - Grime - Small / (L) Front Trim - Grime - Small / Ceiling - Grime - Small / Overall Interior - Smell - Yes</p> | <p><b>Remarks</b><br/>(R) Front Fender - Repair Traces - Yes / (L) Rear Fender - Repair Traces - Yes / (R) Rear Fender - Repair Traces - Yes / Roof - Repair Traces - Yes / (R) Rear Fender, Molding - Repair mark - Yes / (L) Rear Fender, Molding - Repair mark - Yes / Roof - Repair mark - Yes / (L) Front Fender, Molding - Dent - Medium / (R) Step, In-panel, Side Spoiler - Scratch &amp; Dent - Large / Rear Bumper, Lamps, Panels - Scratch - Medium / Trunk Hood, Rear Gate - Dent - Small / (R) Mirror - Scratch - Minimal / (L) Rear Door, Molding - Scratch - Small / (L) Mirror - Scratch - Minimal / Front Bumper, Grille, Lamps - Scratch &amp; Dent - Large</p> |
