## General Information

<b>Make</b>	Toyota	<b>Model</b>	Hiace
<b>YOM</b>	2017	<b>Odo Meter Reading</b>	83,563
<b>Registration No.</b>	DAI2064	<b>Chassis No.</b>	JTFST23P8G0029879
<b>CC</b>	3.0	<b>Transmission</b>	A/T
<b>Fuel Type</b>	Diesel	<b>Type of Body</b>	Van
<b>Colour</b>	White

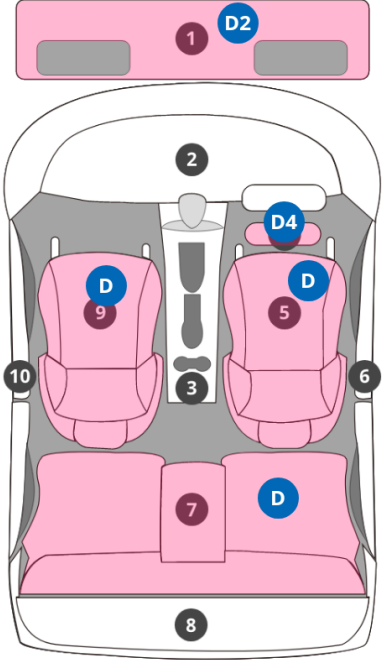
<b>Interior Evaluation :</b> <span style="float: right; color: red; font-weight: bold;">C</span>	<b>Exterior Evaluation :</b> <span style="float: right; color: red; font-weight: bold;">B</span>

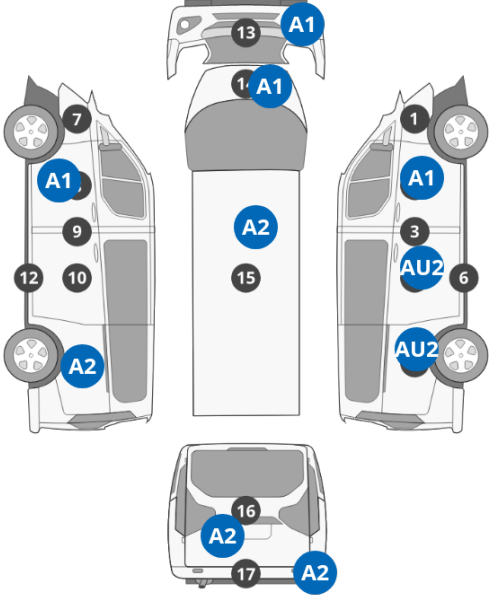
<p><b>A</b> : Scratch <b>AU</b> : Scratch &amp; Dent <b>B</b> : Modified <b>C</b> : Corrosion <b>G</b> : Stone chip <b>P</b> : Faded <b>S</b> : Rust <b>SC</b> : Rust &amp; Corrosion <b>U</b> : Dent <b>X</b> : Defective <b>Y</b> : Crack, Gap</p>
<p><b>Remarks</b> Overall Interior - Worn as per age - Yes / Ceiling - Crinkle - Small / (L) Front Seat - Worn - Yes / (R) Front Seat - Worn - Yes / Rear Seat - Worn - Yes / (L) Front Floor Mat - Worked - Large</p>	<p><b>Remarks</b> (R) Rear Fender, Molding - Scratch &amp; Dent - Small / Rear Bumper, Lamps, Panels - Scratch - Small / Trunk Hood, Rear Gate - Scratch - Small / (L) Rear Fender, Molding - Scratch - Small / (R) Rear Door, Molding - Scratch &amp; Dent - Small / (R) Front Door, Molding - Scratch - Minimal / Bonnet, Headlight - Scratch - Minimal / Front Bumper, Grille, Lamps - Scratch - Minimal / (L) Front Door, Molding - Scratch - Minimal / Roof - Scratch - Small</p>
