## General Information

Date & Time: 01, Aug, 2025 10:17

<b>Make</b>	Lexus	<b>Model</b>	ES
<b>YOM</b>	2018	<b>Odo Meter Reading</b>	72,418
<b>Registration No.</b>	DAM6917	<b>Chassis No.</b>	JTHBZ1B13J2001089
<b>CC</b>	3.5	<b>Transmission</b>	A/T
<b>Fuel Type</b>	Gas	<b>Type of Body</b>	Sedan
<b>Colour</b>	Gray

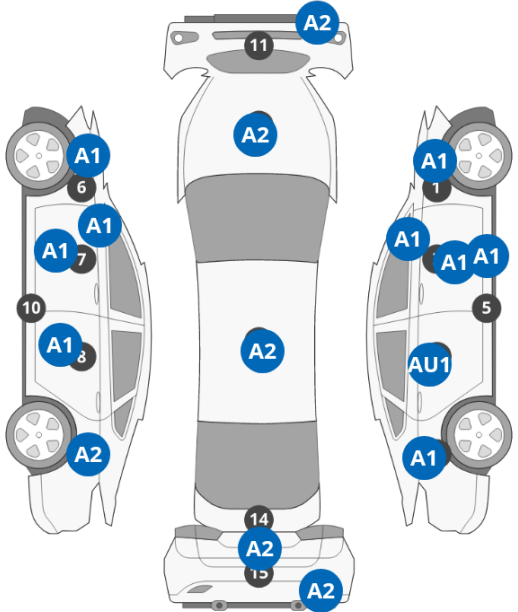
<p><b>A</b> : Scratch <b>AU</b> : Scratch &amp; Dent <b>B</b> : Modified <b>C</b> : Corrosion <b>G</b> : Stone chip <b>P</b> : Faded <b>S</b> : Rust <b>SC</b> : Rust &amp; Corrosion <b>U</b> : Dent <b>X</b> : Defective <b>Y</b> : Crack, Gap</p>
<p><b>Remarks</b> Ceiling - Grime - Small / (L) Front Trim - Worked - Small / (R) Front Trim - Worked - Small</p>	<p><b>Remarks</b> (L) Front Door, Molding - Scratch - Minimal / (L) Rear Door, Molding - Scratch - Minimal / (L) Front Fender, Molding - Scratch - Minimal / Bonnet, Headlight - Scratch - Small / Front Bumper, Grille, Lamps - Scratch - Small / (R) Front Fender, Molding - Scratch - Minimal / (R) Front Door, Molding - Scratch - Minimal / (R) Step, In-panel, Side Spoiler - Scratch - Minimal / (R) Rear Fender, Molding - Scratch - Minimal / Rear Bumper, Lamps, Panels - Scratch - Small / Trunk Hood, Rear Gate - Scratch - Small / (L) Rear Fender, Molding - Scratch - Small / Roof - Scratch - Small / (R) Rear Door, Molding - Scratch &amp; Dent - Minimal / (R) Mirror - Scratch - Minimal / (L) Mirror - Scratch - Minimal</p>
