General Information

| Make | Toyota | Model | Vios |
| YOM | 2019 | Odo Meter Reading | 121,384 |
| Registration No. | DAM8363 | Chassis No. | PA1B13F39J4072421 |

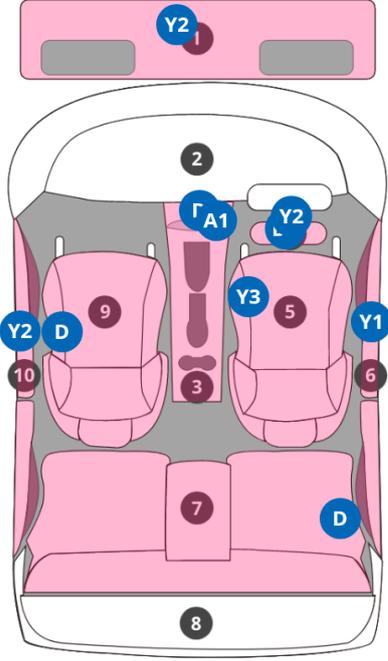
| Interior Evaluation : C | Exterior Evaluation : C |
| <p>Remarks Overall Interior - Worn as per age - Yes / Rear Seat - Worn - Yes / (L) Front Seat - Worn - Yes / (R) Front Seat - Grime - Medium / (R) Front Trim - Grime - Minimal / (L) Front Floor Mat - Worked - Large / (L) Front Floor Mat - Grime - Small / (L) Front Trim - Grime - Small / Console, Switchs, Vents - Traces of Adhesive Tape - Yes / Ceiling - Grime - Small / Console, Switchs, Vents - Worn, Scratch, Cut, Crack - Minimal</p> | <p>Remarks (R) Mirror - Scratch - Minimal / (R) Front Door, Molding - Scratch - Small / (R) Rear Door, Molding - Scratch - Small / (R) Rear Fender, Molding - Scratch & Dent - Minimal / Member (Bolted) - Dent - Yes / Rear Bumper, Lamps, Panels - Scratch - Small / Trunk Hood, Rear Gate - Scratch & Dent - Medium / (L) Rear Fender, Molding - Scratch - Small / (L) Rear Door, Molding - Scratch - Small / (L) Front Door, Molding - Scratch & Dent - Small / (L) Step, In-panel, Side Spoiler - Scratch & Dent - Medium / (L) Mirror - Scratch - Minimal / (L) Front Fender, Molding - Scratch - Small / Front Bumper, Grille, Lamps - Scratch & Dent - Small / Bonnet, Headlight - Scratch - Minimal / Roof - Scratch - Minimal / (R) Front Fender, Molding - Scratch - Minimal</p> |
