## General Information

<b>Make</b>	Lexus	<b>Model</b>	ES350
<b>YOM</b>	2022	<b>Odo Meter Reading</b>	55,215
<b>Registration No.</b>	DAP6890	<b>Chassis No.</b>	JTHBZ1B13M2016437
<b>CC</b>	3.5	<b>Transmission</b>	A/T
<b>Fuel Type</b>	Gas	<b>Type of Body</b>	Sedan
<b>Colour</b>	Blue

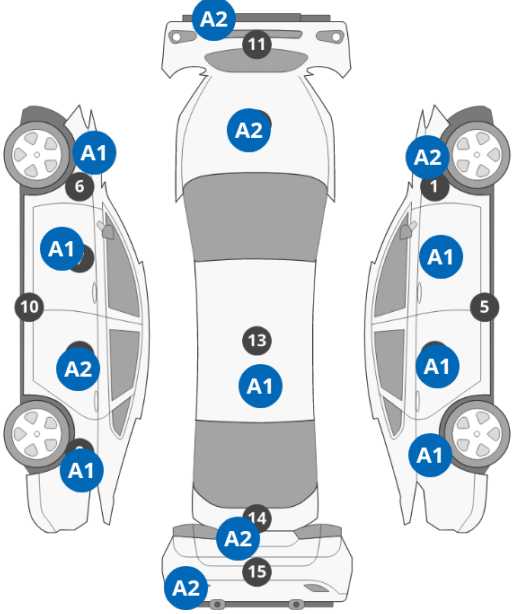
<p><b>A</b> : Scratch <b>AU</b> : Scratch &amp; Dent <b>B</b> : Modified <b>C</b> : Corrosion <b>G</b> : Stone chip <b>P</b> : Faded <b>S</b> : Rust <b>SC</b> : Rust &amp; Corrosion <b>U</b> : Dent <b>X</b> : Defective <b>Y</b> : Crack, Gap</p>
<p><b>Remarks</b> (L) Front Floor Mat - Worked - Small</p>	<p><b>Remarks</b> (R) Rear Door, Molding - Scratch - Minimal / (R) Front Door, Molding - Scratch - Minimal / (R) Rear Fender, Molding - Scratch - Minimal / Rear Bumper, Lamps, Panels - Scratch - Small / Trunk Hood, Rear Gate - Scratch - Small / (L) Rear Fender, Molding - Scratch - Minimal / (L) Rear Door, Molding - Scratch - Small / (L) Front Door, Molding - Scratch - Minimal / (L) Front Fender, Molding - Scratch - Minimal / Front Bumper, Grille, Lamps - Scratch - Small / Bonnet, Headlight - Scratch - Small / (R) Front Fender, Molding - Scratch - Small / Roof - Scratch - Minimal</p>
