## General Information

Date & Time: 25, Jul, 2025 14:01

<b>Make</b>	Suzuki	<b>Model</b>	Ertiga
<b>YOM</b>	2023	<b>Odo Meter Reading</b>	84,936
<b>Registration No.</b>	NHB6981	<b>Chassis No.</b>	MHYNC22S5PJ107388
<b>CC</b>	1.5	<b>Transmission</b>	M/T
<b>Fuel Type</b>	Gas	<b>Type of Body</b>	MPV
<b>Colour</b>	White

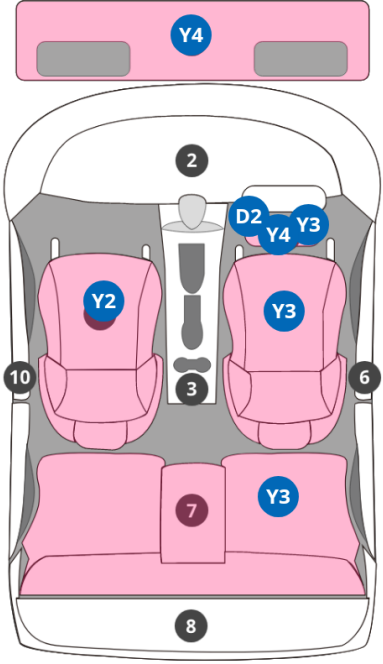
<b>Interior Evaluation :</b> <span style="float: right; color: red; font-weight: bold;">C</span>	<b>Exterior Evaluation :</b> <span style="float: right; color: red; font-weight: bold;">E</span>

<p><b>a</b> : Cut, Fray <b>d</b> : Loose, Deformed <b>k</b> : Animal Hair <b>s</b> : Smell <b>t</b> : Cigarette Burns <b>x</b> : Defective <b>y</b> : Stain</p>

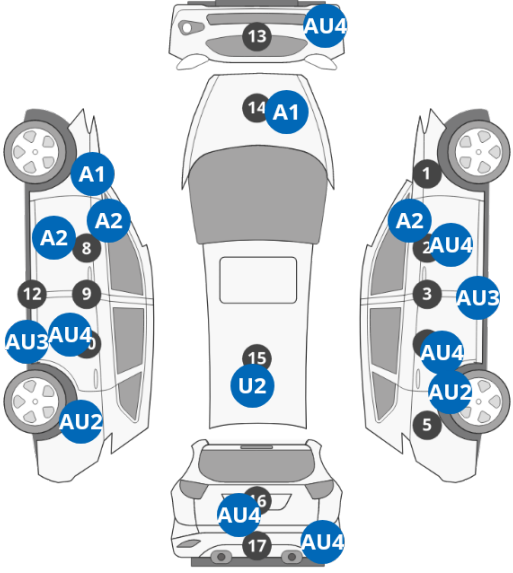
<p><b>A</b> : Scratch <b>AU</b> : Scratch &amp; Dent <b>B</b> : Modified <b>C</b> : Corrosion <b>G</b> : Stone chip <b>P</b> : Faded <b>S</b> : Rust <b>SC</b> : Rust &amp; Corrosion <b>U</b> : Dent <b>X</b> : Defective <b>Y</b> : Crack, Gap</p>
<p><b>Remarks</b> Ceiling - Grime - Large / (R) Front Seat - Grime - Medium / (R) Front Floor Mat - Grime - Medium / Rear Seat - Grime - Medium / Mat Other - Grime - Large / (L) Front Seat - Grime - Small / (L) Front Floor Mat - Worked - Small</p>	<p><b>Remarks</b> (R) Front Door, Molding - Scratch &amp; Dent - Large / (R) Rear Door, Molding - Scratch &amp; Dent - Large / (R) Step, In-panel, Side Spoiler - Scratch &amp; Dent - Medium / (R) Rear Fender, Molding - Scratch &amp; Dent - Small / Trunk Hood, Rear Gate - Scratch &amp; Dent - Large / Rear Bumper, Lamps, Panels - Scratch &amp; Dent - Large / (L) Rear Fender, Molding - Scratch &amp; Dent - Small / (L) Step, In-panel, Side Spoiler - Scratch &amp; Dent - Medium / (L) Rear Door, Molding - Scratch &amp; Dent - Large / (L) Mirror - Scratch - Small / (L) Front Door, Molding - Scratch - Small / (L) Front Fender, Molding - Scratch - Minimal / Front Bumper, Grille, Lamps - Scratch &amp; Dent - Large / Bonnet, Headlight - Scratch - Minimal / (R) Mirror - Scratch - Small / Roof - Dent - Small</p>
