## General Information

Date & Time: 04, Aug, 2025 12:46

| Make | Toyota | Model | Vios |
| YOM | 2023 | Odo Meter Reading | 25,209 |

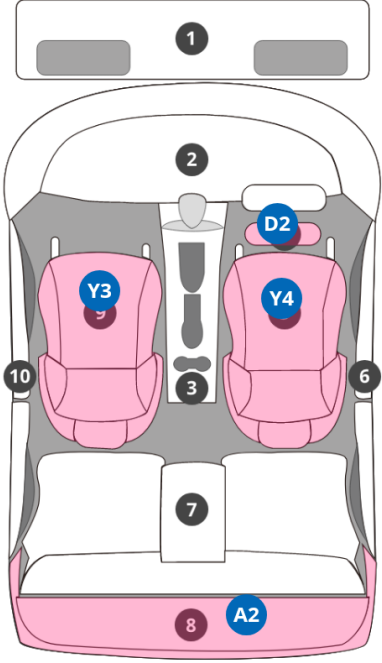
| Interior Evaluation : <b>C</b> | Exterior Evaluation : <b>D</b> |
| <p><b>Remarks</b></p> <p>Trunk Room - Worn, Scratch, Cut, Crack - Small / (R)<br/>Front Seat - Grime - Large / (L) Front Seat - Grime - Medium / (L) Front Floor Mat - Worked - Small</p> | <p><b>Remarks</b></p> <p>(R) Front Fender - Repair Traces - Yes / Bonnet - Repair Traces - Yes / (L) Front Fender - Repair Traces - Yes / (L) Rear Fender - Repair Traces - Yes / (L) Rear Fender, Molding - Repair mark - Yes / Bonnet, Headlight - Repair mark - Yes / (R) Front Fender, Molding - Repair mark - Yes / (L) Front Fender, Molding - Repair mark - Yes / Front Bumper, Grille, Lamps - Repair mark - Yes / (R) Front Fender, Molding - Scratch - Minimal / (R) Mirror - Scratch - Minimal / (R) Front Door, Molding - Scratch - Minimal / (R) Rear Door, Molding - Scratch - Small / (R) Rear Fender, Molding - Scratch - Small / Rear Bumper, Lamps, Panels - Repair mark - Yes / Trunk Hood, Rear Gate - Scratch - Small / Rear Bumper, Lamps, Panels - Scratch - Medium / (L) Rear Fender, Molding - Scratch - Minimal / (L) Rear Door, Molding - Scratch - Minimal / (L) Front Door, Molding - Scratch - Minimal / (L) Step, In-panel, Side Spoiler - Scratch - Small / (L) Front Fender, Molding - Scratch - Minimal / Front Bumper, Grille, Lamps - Scratch - Medium / Bonnet, Headlight - Scratch - Small / Roof - Scratch - Small</p> |
