## General Information

| Make | Toyota | Model | Vios |
| Registration No. | NKA3696 | Chassis No. | PA1B18F3XR4245971 |

## Overall Evaluation :

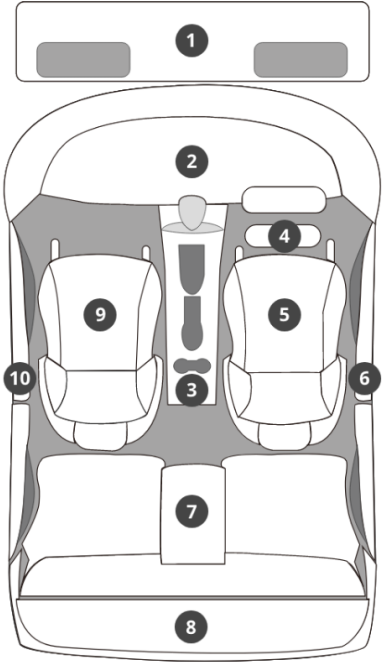
| Interior Evaluation : <span style="color: red;">A</span> | Exterior Evaluation : <span style="color: red;">C</span> |
| <b>Remarks</b><br>Defects not found | <b>Remarks</b><br>Bonnet, Headlight - Scratch & Dent - Large / (R) Front Fender, Molding - Dent - Small / Front Bumper, Grille, Lamps - Scratch & Dent - Large / (R) Front Door, Molding - Scratch - Small / (R) Rear Fender, Molding - Dent - Minimal / Rear Bumper, Lamps, Panels - Dent - Minimal / Roof - Dent - Small / (L) Rear Door, Molding - Dent - Minimal |
