## General Information

<b>Make</b>	Toyota	<b>Model</b>	Vios
<b>YOM</b>	2024	<b>Odo Meter Reading</b>	9,822
<b>Registration No.</b>	DBO9650	<b>Chassis No.</b>	PA1B18F3R4259884
<b>CC</b>	1.3	<b>Transmission</b>	CVT
<b>Fuel Type</b>	Gas	<b>Type of Body</b>	Sedan
<b>Colour</b>	Black

## Body / Panel Condition

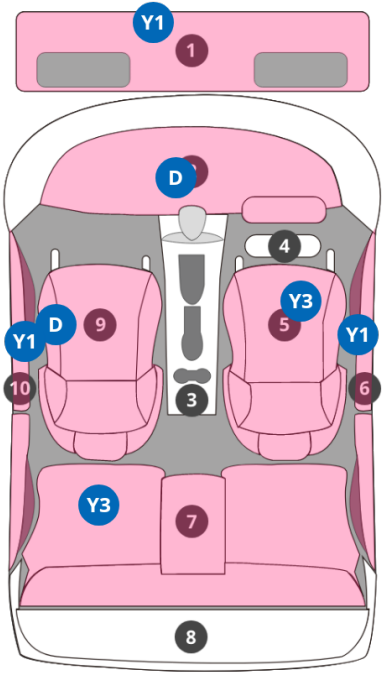
<b>Interior Evaluation :</b> <span style="float: right; color: red; font-weight: bold;">B</span>	<b>Exterior Evaluation :</b> <span style="float: right; color: red; font-weight: bold;">D</span>

<p><b>a</b> : Cut, Fray <b>d</b> : Loose, Deformed <b>k</b> : Animal Hair <b>s</b> : Smell <b>t</b> : Cigarette Burns <b>x</b> : Defective <b>y</b> : Stain</p>

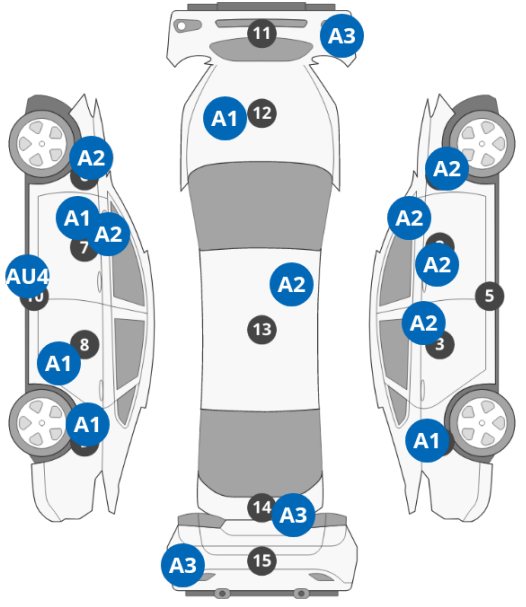
<p><b>A</b> : Scratch <b>AU</b> : Scratch &amp; Dent <b>B</b> : Modified <b>C</b> : Corrosion <b>G</b> : Stone chip <b>P</b> : Faded <b>S</b> : Rust <b>SC</b> : Rust &amp; Corrosion <b>U</b> : Dent <b>X</b> : Defective <b>Y</b> : Crack, Gap</p>
<p><b>Remarks</b> Rear Seat - Grime - Medium / (L) Front Seat - Worn - Yes / (R) Front Seat - Grime - Medium / (R) Front Trim - Grime - Minimal / (L) Front Trim - Grime - Minimal / Ceiling - Grime - Minimal / Dashboard - Traces of Adhesive Tape - Yes</p>	<p><b>Remarks</b> (R) Front Fender, Molding - Scratch - Small / (R) Mirror - Scratch - Small / (R) Front Door, Molding - Scratch - Small / (R) Rear Door, Molding - Scratch - Small / (R) Rear Fender, Molding - Scratch - Minimal / Rear Bumper, Lamps, Panels - Scratch - Medium / Trunk Hood, Rear Gate - Scratch - Medium / (L) Step, In-panel, Side Spoiler - Scratch &amp; Dent - Large / (L) Rear Fender, Molding - Scratch - Minimal / (L) Front Door, Molding - Scratch - Minimal / (L) Rear Door, Molding - Scratch - Minimal / (L) Mirror - Scratch - Small / (L) Front Fender, Molding - Scratch - Small / Front Bumper, Grille, Lamps - Scratch - Medium / Bonnet, Headlight - Scratch - Minimal / Roof - Scratch - Small</p>
