## General Information

| Make | Toyota | Model | Vios |
| Registration No. | NHG2134 | Chassis No. | PA1B18F30P4233440 |

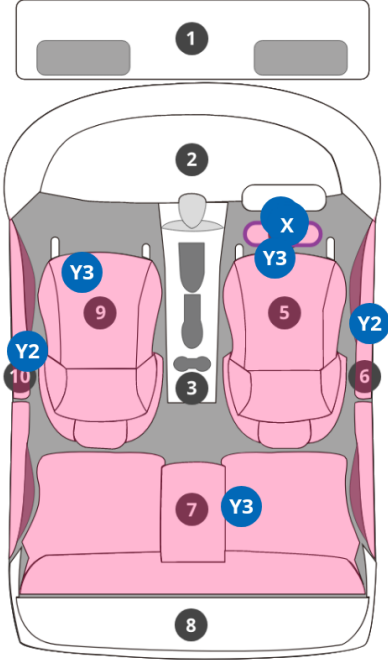
| Interior Evaluation : <b>B</b> | Exterior Evaluation : <b>C</b> |
|---|---|
| <p><b>Remarks</b></p> <p>Mat Other - Missing - Yes / (R) Front Floor Mat - Missing - Yes / (L) Front Floor Mat - Missing - Yes / (R) Front Trim - Grime - Small / (R) Front Seat - Grime - Medium / (L) Front Seat - Grime - Medium / Rear Seat - Grime - Medium / (L) Front Trim - Grime - Small</p> | <p><b>Remarks</b></p> <p>(R) Front Fender - Repair Traces - Yes / (L) Front Door - Repair Traces - Yes / Trunk Hood, Rear Gate - Repair Traces - Yes / (R) Front Fender, Molding - Scratch - Minimal / (R) Mirror - Scratch - Minimal / (R) Front Door, Molding - Scratch - Minimal / (R) Rear Door, Molding - Scratch - Minimal / (R) Rear Fender, Molding - Scratch - Minimal / Rear Bumper, Lamps, Panels - Repair mark - Yes / Rear Bumper, Lamps, Panels - Scratch - Small / Trunk Hood, Rear Gate - Scratch - Small / (L) Front Door, Molding - Scratch - Minimal / (L) Mirror - Scratch - Minimal / (L) Mirror - Crack - Cracks / (L) Front Fender, Molding - Scratch - Minimal / Front Bumper, Grille, Lamps - Scratch - Small / Front Bumper, Grille, Lamps - Repair mark - Yes / Roof - Scratch - Small / Bonnet, Headlight - Scratch - Minimal</p> |

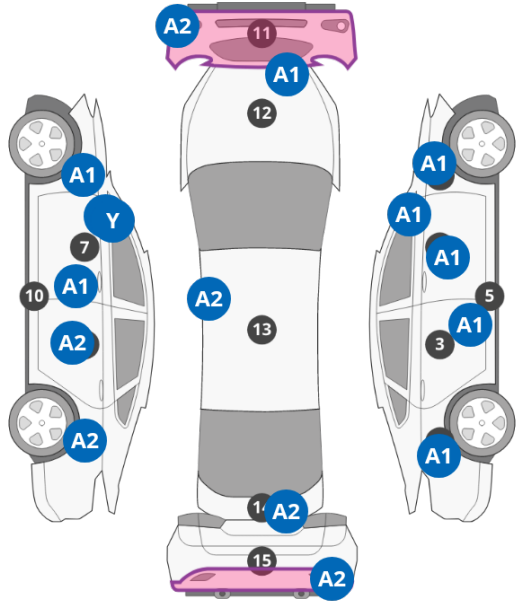
| Inspector Notes |
|---|
| no warranty booklet, with jack, no tools, no spare tire, no LTO plate, scratches on tail light, cracked left side mirror |
