General Information

Make	Suzuki	Model	Ertiga
YOM	2018	Odo Meter Reading	50,841
Registration No.	NBP9274	Chassis No.	MHYZE81S1KJ303160
CC	1.3	Transmission	M/T
Fuel Type	Gas	Type of Body	Wagon
Colour	Gray

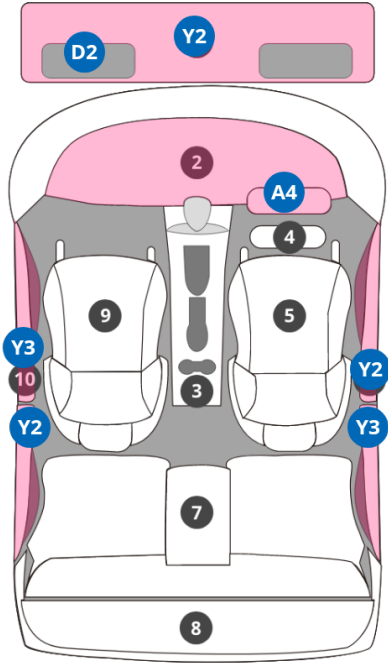
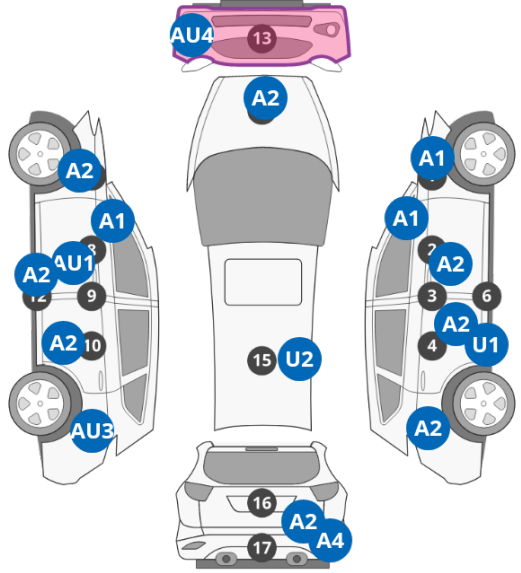
Interior Evaluation :	C	Exterior Evaluation :	E

<p>a : Cut, Fray d : Loose, Deformed k : Animal Hair s : Smell t : Cigarette Burns x : Defective y : Stain</p>		<p>A : Scratch AU : Scratch & Dent B : Modified C : Corrosion G : Stone chip P : Faded S : Rust SC : Rust & Corrosion U : Dent X : Defective Y : Crack, Gap</p>	
<p>Remarks Ceiling - Grime - Small / (R) Front Trim - Grime - Small / (R) Rear Trim - Grime - Medium / (L) Rear Trim - Grime - Small / (L) Front Trim - Grime - Medium / Steering Wheel - Worn, Peel, Crack - Large / Sunvisor, Sunglass Holder - Crinkle - Small / Room Mirror - Partially Missing - Yes</p>		<p>Remarks Bonnet - Repair Traces - Yes / (L) Front Fender - Repair Traces - Yes / (L) Rear Fender, Molding - Scratch & Dent - Medium / (L) Rear Door, Molding - Scratch - Small / (L) Mirror - Scratch - Minimal / (L) Front Door, Molding - Scratch & Dent - Minimal / (L) Front Fender, Molding - Scratch - Small / (R) Mirror - Scratch - Minimal / (R) Front Door, Molding - Scratch - Small / (R) Rear Door, Molding - Scratch - Small / (R) Rear Fender, Molding - Scratch - Small / Rear Bumper, Lamps, Panels - Scratch - Large / Trunk Hood, Rear Gate - Scratch - Small / Front Bumper, Grille, Lamps - Repair mark - Yes / Front Bumper, Grille, Lamps - Scratch & Dent - Large / Bonnet, Headlight - Scratch - Small / Roof - Dent - Small / (R) Step, In-panel, Side Spoiler - Dent - Minimal / (L) Step, In-panel, Side Spoiler - Scratch - Small / (R) Front Fender, Molding - Scratch - Minimal</p>
