## General Information

<b>Make</b>	Ford	<b>Model</b>	Everest
<b>YOM</b>	2017	<b>Odo Meter Reading</b>	8,939
<b>Registration No.</b>	NAE8939	<b>Chassis No.</b>	MNCAXXMAWAGS00029
<b>CC</b>	2.2	<b>Transmission</b>	A/T
<b>Fuel Type</b>	Diesel	<b>Type of Body</b>	Wagon
<b>Colour</b>	White

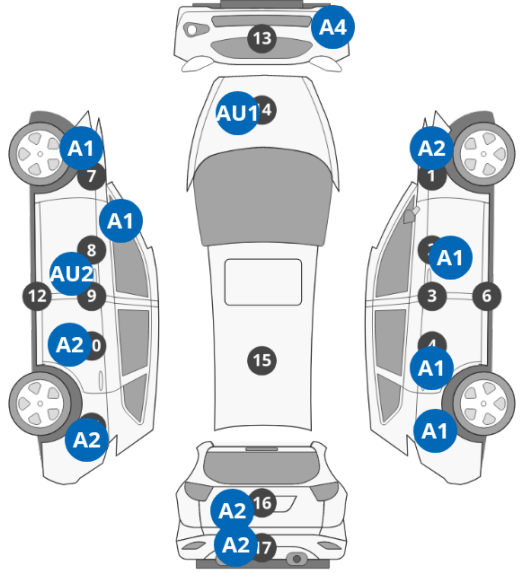
<p><b>A</b> : Scratch <b>AU</b> : Scratch &amp; Dent <b>B</b> : Modified <b>C</b> : Corrosion <b>G</b> : Stone chip <b>P</b> : Faded <b>S</b> : Rust <b>SC</b> : Rust &amp; Corrosion <b>U</b> : Dent <b>X</b> : Defective <b>Y</b> : Crack, Gap</p>
<p><b>Remarks</b> Ceiling - Grime - Small / Sunvisor, Sunglass Holder - Grime - Medium / (R) Front Trim - Grime - Small / (R) Rear Trim - Grime - Small / (L) Rear Trim - Loose, Deformed - Large / (L) Front Trim - Grime - Small / (L) Front Seat - Cut, Crack - Medium / Steering Wheel - Worn, Peel, Crack - Large</p>	<p><b>Remarks</b> (R) Front Door - Repair Traces - Yes / (R) Front Fender, Molding - Scratch - Small / (R) Front Door, Molding - Scratch - Minimal / (R) Rear Door, Molding - Scratch - Minimal / (R) Rear Fender, Molding - Scratch - Minimal / Rear Bumper, Lamps, Panels - Scratch - Small / Trunk Hood, Rear Gate - Scratch - Small / (L) Rear Fender, Molding - Scratch - Small / (L) Rear Door, Molding - Scratch - Small / (L) Front Door, Molding - Scratch &amp; Dent - Small / (L) Mirror - Scratch - Minimal / (L) Front Fender, Molding - Scratch - Minimal / Bonnet, Headlight - Scratch &amp; Dent - Minimal / Front Bumper, Grille, Lamps - Scratch - Large</p>
