## General Information

| Make | Toyota | Model | Avanza |
| Registration No. | DBQ2952 | Chassis No. | MHFAA1BY4R0027004 |

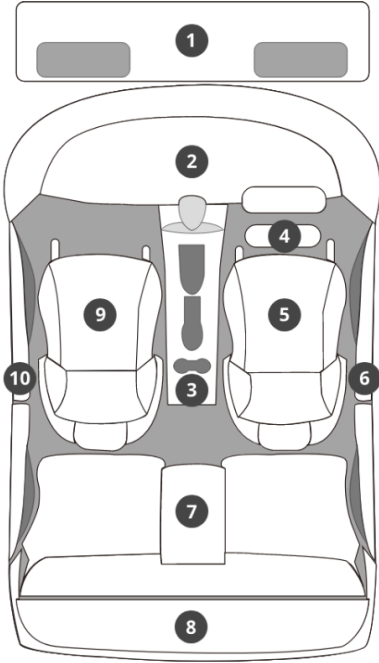
| Interior Evaluation : <span style="color: red; font-weight: bold;">A</span> | Exterior Evaluation : <span style="color: red; font-weight: bold;">C</span> |
| <b>Remarks</b><br>Defects not found | <b>Remarks</b><br>(R) Front Door - Repair Traces - Yes / (R) Front Fender - Repair Traces - Yes / (L) Front Door - Repair Traces - Yes / Trunk Hood, Rear Gate - Repair Traces - Yes / (R) Front Fender, Molding - Scratch - Minimal / (R) Mirror - Scratch - Minimal / (R) Front Door, Molding - Scratch - Medium / (R) Rear Door, Molding - Scratch - Minimal / Rear Bumper, Lamps, Panels - Scratch - Small / Trunk Hood, Rear Gate - Scratch - Minimal / (L) Rear Fender, Molding - Scratch - Small / (L) Front Door, Molding - Scratch & Dent - Minimal / (L) Rear Door, Molding - Scratch - Minimal / (L) Mirror - Scratch - Small / Front Bumper, Grille, Lamps - Scratch & Dent - Medium / Bonnet, Headlight - Scratch - Minimal / Roof - Scratch - Minimal |
