General Information

Make	Ford	Model	Ranger
YOM	2018	Odo Meter Reading	69,870
Registration No.	NCW2322	Chassis No.	MNCLMFF80JW841716
CC	2.2	Transmission	M/T
Fuel Type	Diesel	Type of Body	Pickup
Colour	Gray

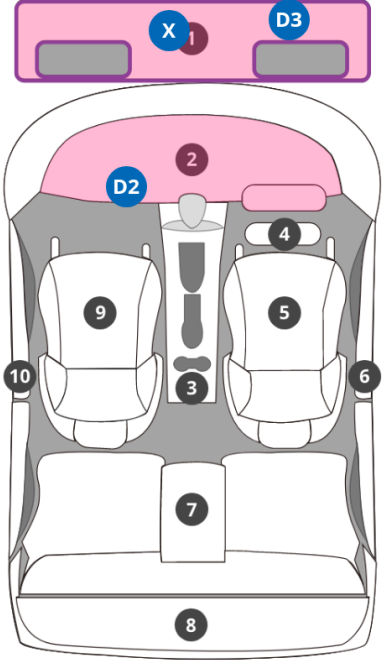
Interior Evaluation : C	Exterior Evaluation : C

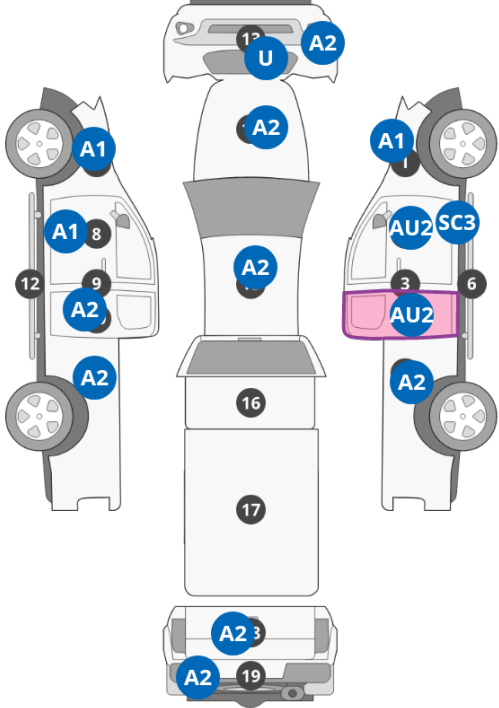
<p>A : Scratch AU : Scratch & Dent B : Modified C : Corrosion G : Stone chip P : Faded S : Rust SC : Rust & Corrosion U : Dent X : Defective Y : Crack, Gap</p>
<p>Remarks Overall Interior - Worn as per age - Yes / Ceiling - Crinkle - Medium / Dashboard - Loose, Deformed - Small / Sunvisor, Sunglass Holder - Missing - Yes</p>	<p>Remarks (R) Rear Door - Repair Traces - Yes / (R) Rear Door, Molding - Repair mark - Yes / (R) Step, In-panel, Side Spoiler - Rust, Corrosion - Medium / (R) Front Door, Molding - Scratch & Dent - Small / (R) Rear Door, Molding - Scratch & Dent - Small / (R) Side Gate - Scratch - Small / (R) Front Fender, Molding - Scratch - Minimal / (L) Front Fender, Molding - Scratch - Minimal / (L) Front Door, Molding - Scratch - Minimal / (L) Rear Door, Molding - Scratch - Small / (L) Side Gate - Scratch - Small / Rear Gate - Scratch - Small / Rear Bumper, Lamps, Panels - Scratch - Small / Roof - Scratch - Small / Bonnet, Headlight - Scratch - Small / Front Bumper, Grille, Lamps - Scratch - Small / Member (Bolted) - Dent - Yes</p>
