## General Information

| Make | Toyota | Model | Vios |
| Registration No. | NEV8259 | Chassis No. | PA1B18F3XM4156491 |

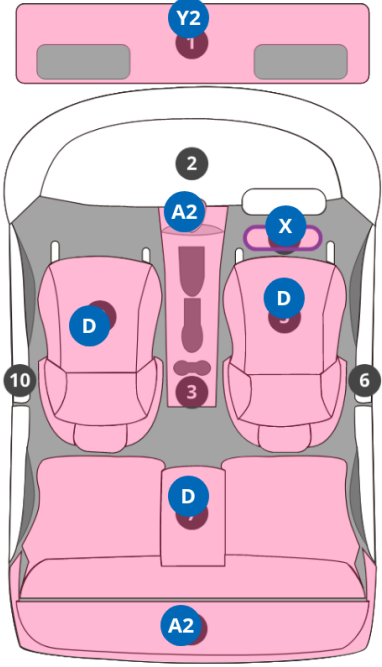
| Interior Evaluation : <span style="color: red;">C</span> | Exterior Evaluation : <span style="color: red;">E</span> |
| <b>Remarks</b><br>Mat Other - Missing - Yes / Trunk Room - Worn, Scratch, Cut, Crack - Small / Rear Seat - Worn - Yes / Ceiling - Grime - Small / (L) Front Seat - Worn - Yes / (R) Front Seat - Worn - Yes / Console, Switchs, Vents - Worn, Scratch, Cut, Crack - Small / Overall Interior - Worn as per age - Yes | <b>Remarks</b><br>(R) Front Door - Repair Traces - Yes / (R) Step - Repair Traces - Yes / (R) Front Fender - Repair Traces - Yes / Bonnet - Repair Traces - Yes / (L) Front Fender - Repair Traces - Yes / (L) Front Door - Repair Traces - Yes / (L) Step - Repair Traces - Yes / (L) Rear Door - Repair Traces - Yes / (L) Rear Fender - Repair Traces - Yes / Trunk Hood, Rear Gate - Repair Traces - Yes / (R) Rear Fender - Repair Traces - Yes / (R) Rear Door - Repair Traces - Yes / Roof - Repair Traces - Yes / Member (Bolted) - Dent - Yes / Overall Exterior - Full Re-Paint in same color - Yes / Overall Exterior - Re-Paint Uneven - Yes / (R) Front Fender, Molding - Scratch - Small / (R) Mirror - Scratch - Minimal / (R) Front Door, Molding - Scratch - Small / (R) Rear Door, Molding - Scratch - Small / (R) Rear Fender, Molding - Scratch & Dent - Small / Rear Bumper, Lamps, Panels - Rust, Corrosion - Large / Trunk Hood, Rear Gate - Scratch - Small / (L) Rear Fender, Molding - Scratch - Medium / (L) Rear Door, Molding - Scratch - Small / (L) Front Door, Molding - Scratch - Medium / (L) Mirror - Scratch - Small / (L) Front Fender, Molding - Scratch - Medium / Front Bumper, Grille, Lamps - Rust, Corrosion - Medium / Bonnet, Headlight - Scratch - Small / Roof - Scratch - Minimal |

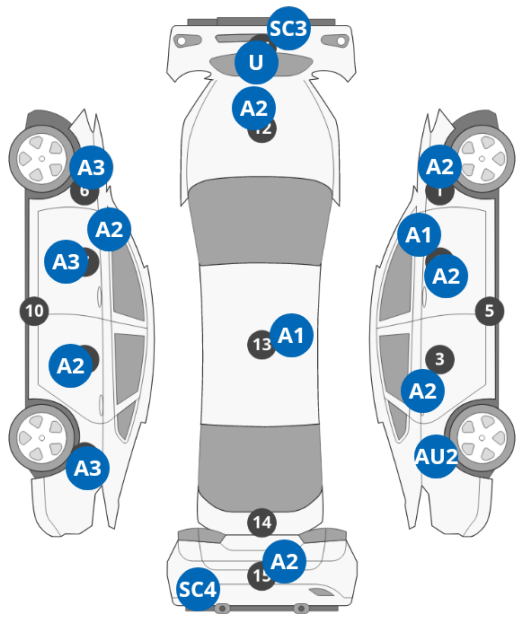
| Inspector Notes |
|---|
| no LTO plate, no warranty booklet, no jack and tools, no spare tire, replacement plate, loosed front left door trim, busted headlight, loosed left cheek light, missing trunk floor bed cover, scratches on headlight |
