General Information

Make	Suzuki	Model	Ertiga
YOM	2022	Odo Meter Reading	40,840
Registration No.	NFD8710	Chassis No.	MHYNC22SOPJ103524
CC	1.5	Transmission	A/T
Fuel Type	Gas	Type of Body	Wagon
Colour	Brown

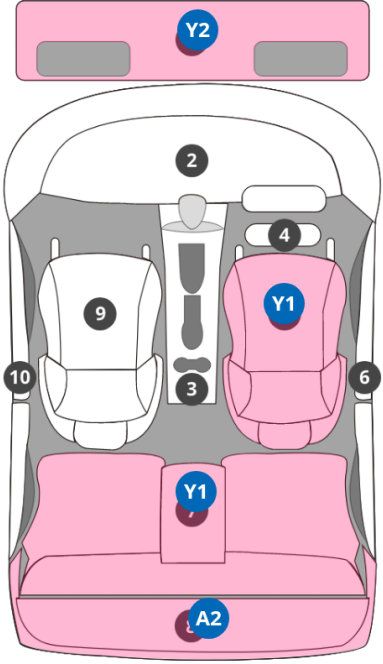
<p>a : Cut, Fray d : Loose, Deformed k : Animal Hair s : Smell t : Cigarette Burns x : Defective y : Stain</p>

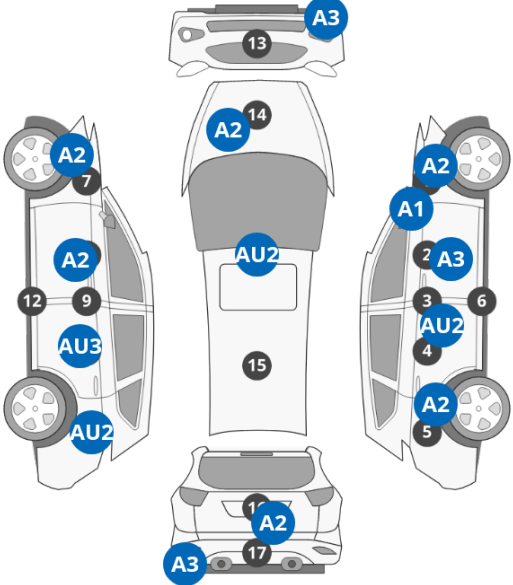
<p>A : Scratch AU : Scratch & Dent B : Modified C : Corrosion G : Stone chip P : Faded S : Rust SC : Rust & Corrosion U : Dent X : Defective Y : Crack, Gap</p>
<p>Remarks Trunk Room - Worn, Scratch, Cut, Crack - Small / Ceiling - Grime - Small / Rear Seat - Grime - Minimal / (R) Front Seat - Grime - Minimal</p>	<p>Remarks (R) Front Fender - Repair Traces - Yes / (L) Front Fender - Repair Traces - Yes / (R) Front Fender, Molding - Scratch - Small / Overall Exterior - Full Re-Paint in same color - Yes / (R) Mirror - Scratch - Minimal / (R) Front Door, Molding - Scratch - Medium / (R) Rear Door, Molding - Scratch & Dent - Small / (R) Rear Fender, Molding - Scratch - Small / Rear Bumper, Lamps, Panels - Scratch - Medium / Trunk Hood, Rear Gate - Scratch - Small / (L) Rear Fender, Molding - Scratch & Dent - Small / (L) Rear Door, Molding - Scratch & Dent - Medium / (L) Front Door, Molding - Scratch - Small / (L) Front Fender, Molding - Scratch - Small / Front Bumper, Grille, Lamps - Scratch - Medium / Roof - Scratch & Dent - Small / Bonnet, Headlight - Scratch - Small</p>
