## General Information

<b>Make</b>	Toyota	<b>Model</b>	Vios
<b>YOM</b>	2024	<b>Odo Meter Reading</b>	14,356
<b>Registration No.</b>	NFR2099	<b>Chassis No.</b>	PA1B18F36R4248866
<b>CC</b>	1.3	<b>Transmission</b>	CVT
<b>Fuel Type</b>	Gas	<b>Type of Body</b>	Sedan
<b>Colour</b>	Black

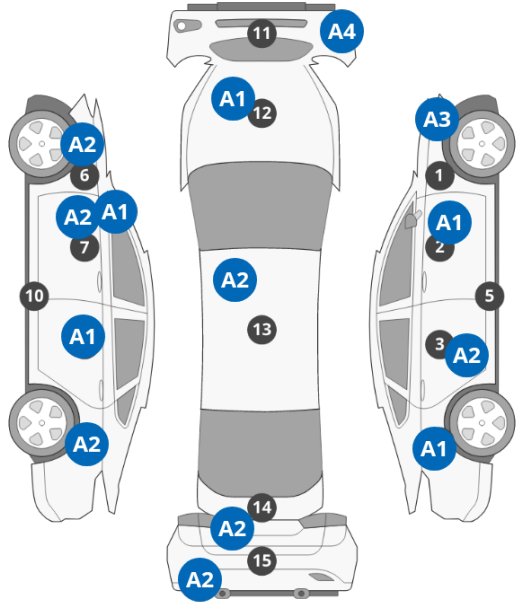
<p><b>A</b> : Scratch <b>AU</b> : Scratch &amp; Dent <b>B</b> : Modified <b>C</b> : Corrosion <b>G</b> : Stone chip <b>P</b> : Faded <b>S</b> : Rust <b>SC</b> : Rust &amp; Corrosion <b>U</b> : Dent <b>X</b> : Defective <b>Y</b> : Crack, Gap</p>
<p><b>Remarks</b> Trunk Room - Worn, Scratch, Cut, Crack - Minimal / Rear Seat - Grime - Small / Dashboard - Traces of Adhesive Tape - Yes / (L) Front Floor Mat - Grime - Medium / (R) Front Seat - Grime - Medium</p>	<p><b>Remarks</b> (R) Front Fender, Molding - Scratch - Medium / (R) Front Door, Molding - Scratch - Minimal / (R) Rear Door, Molding - Scratch - Small / (R) Rear Fender, Molding - Scratch - Minimal / Rear Bumper, Lamps, Panels - Scratch - Small / Trunk Hood, Rear Gate - Scratch - Small / (L) Rear Fender, Molding - Scratch - Small / (L) Rear Door, Molding - Scratch - Minimal / (L) Mirror - Scratch - Minimal / (L) Front Door, Molding - Scratch - Small / (L) Front Fender, Molding - Scratch - Small / Front Bumper, Grille, Lamps - Scratch - Large / Bonnet, Headlight - Scratch - Minimal / Roof - Scratch - Small</p>

<p><b>Inspector Notes</b></p>
<p>with LTO plate, no warranty booklet, with jack and incomplete tools, with spare tire, scratches on tail light, HPG</p>
