## General Information

| Make | Toyota | Model | Vios |
| Registration No. | DBP5857 | Chassis No. | PA1B18F38R4264342 |

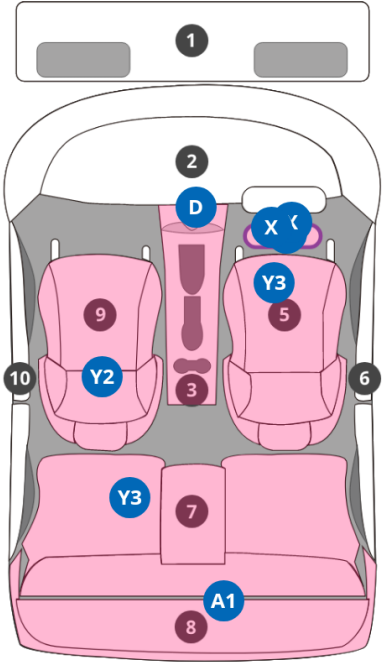
| Interior Evaluation : <b>B</b> | Exterior Evaluation : <b>C</b> |
|---|---|
| <b>Remarks</b><br>Trunk Room - Worn, Scratch, Cut, Crack - Minimal / Mat Other - Missing - Yes / (L) Front Floor Mat - Missing - Yes / (R) Front Floor Mat - Missing - Yes / Rear Seat - Grime - Medium / (R) Front Seat - Grime - Medium / (L) Front Seat - Grime - Small / Console, Switchs, Vents - Traces of Adhesive Tape - Yes | <b>Remarks</b><br>(R) Front Fender, Molding - Scratch - Small / (R) Mirror - Scratch - Minimal / (R) Front Door, Molding - Scratch - Small / (R) Rear Door, Molding - Scratch - Minimal / (R) Rear Fender, Molding - Scratch - Small / Rear Bumper, Lamps, Panels - Crack, Gap - Large / Trunk Hood, Rear Gate - Scratch - Small / (L) Rear Fender, Molding - Scratch - Small / (L) Rear Door, Molding - Scratch - Small / (L) Front Door, Molding - Scratch - Small / (L) Mirror - Scratch - Minimal / Roof - Scratch & Dent - Small / (L) Front Fender, Molding - Scratch - Small / Front Bumper, Grille, Lamps - Scratch - Small / Bonnet, Headlight - Scratch - Small |
