## General Information

| Make | Toyota | Model | Vios |
| Registration No. | NEY9843 | Chassis No. | PA1B18F38R4266883 |

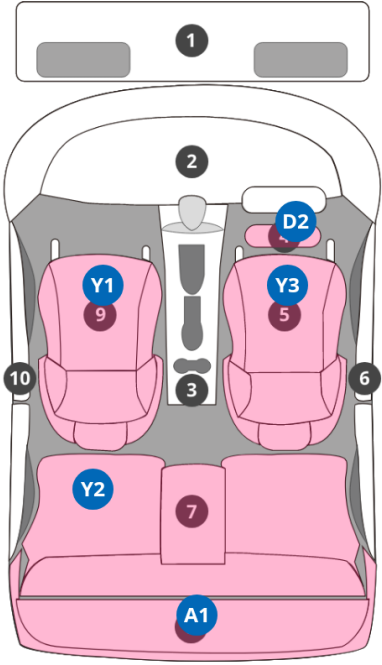
| Interior Evaluation : <b>B</b> | Exterior Evaluation : <b>B</b> |
| <b>Remarks</b><br>Trunk Room - Worn, Scratch, Cut, Crack - Minimal / (R) Front Seat - Grime - Medium / Rear Seat - Grime - Small / (L) Front Seat - Grime - Minimal / (L) Front Floor Mat - Worked - Small | <b>Remarks</b><br>(R) Front Fender, Molding - Scratch - Minimal / (R) Front Door, Molding - Scratch - Minimal / (R) Rear Door, Molding - Scratch - Minimal / (R) Rear Fender, Molding - Scratch - Minimal / Rear Bumper, Lamps, Panels - Scratch - Small / Trunk Hood, Rear Gate - Scratch - Minimal / (L) Rear Fender, Molding - Scratch - Small / (L) Rear Door, Molding - Scratch - Minimal / (L) Front Door, Molding - Scratch - Minimal / (L) Front Fender, Molding - Scratch - Small / Roof - Scratch - Small / Front Bumper, Grille, Lamps - Scratch - Minimal / Bonnet, Headlight - Dent - Minimal |
