## General Information

| Make | Toyota | Model | Vios |
| Registration No. | NKF6675 | Chassis No. | PA1B18F34R4272275 |

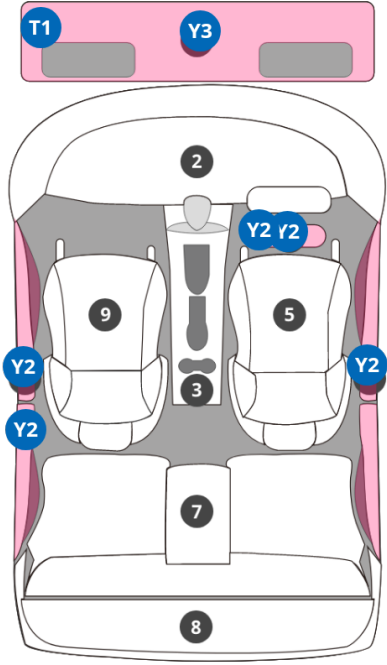
| Interior Evaluation : <b>B</b> | Exterior Evaluation : <b>C</b> |
|---|---|
| <p><b>Remarks</b></p> <p>Ceiling - Grime - Medium / (R) Front Trim - Grime - Small / (L) Rear Trim - Grime - Small / Mat Other - Grime - Small / (L) Front Trim - Grime - Small / (L) Front Floor Mat - Grime - Small / Ceiling - Cigarette Burns - Burnt Minimal</p> | <p><b>Remarks</b></p> <p>Front Bumper, Grille, Lamps - Modified - Large / Front Bumper, Grille, Lamps - Scratch &amp; Dent - Large / (R) Front Fender, Molding - Scratch - Small / (R) Front Door, Molding - Dent - Small / (R) Rear Fender, Molding - Scratch &amp; Dent - Small / Trunk Hood, Rear Gate - Scratch - Small / Rear Bumper, Lamps, Panels - Scratch - Small / (L) Rear Fender, Molding - Scratch - Minimal / (L) Front Door, Molding - Scratch &amp; Dent - Minimal / (L) Mirror - Scratch - Small / (L) Front Fender, Molding - Scratch - Small / Bonnet, Headlight - Scratch - Small</p> |
