## General Information

| Make | Toyota | Model | Vios |
| Registration No. | NGP7823 | Chassis No. | PA1B18F35L4126653 |

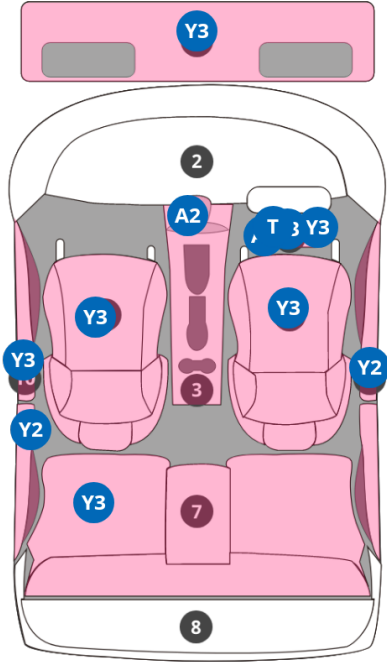
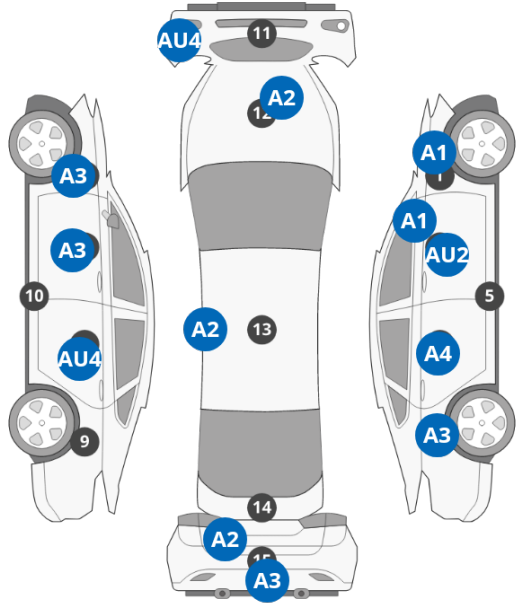
| Interior Evaluation : <b>E</b> | Exterior Evaluation : <b>E</b> |
|---|---|
| <p><b>Remarks</b></p> <p>Ceiling - Grime - Medium / (R) Front Trim - Grime - Small / (R) Front Floor Mat - Grime - Medium / (R) Front Seat - Grime - Medium / Mat Other - Grime - Medium / (L) Rear Trim - Grime - Small / Rear Seat - Grime - Medium / (L) Front Trim - Grime - Medium / (L) Front Seat - Grime - Medium / (L) Front Floor Mat - Cut, Crack - Large / Mat Other - Cigarette Burns - Burnt / Console, Switchs, Vents - Worn, Scratch, Cut, Crack - Small</p> | <p><b>Remarks</b></p> <p>Trunk Hood, Rear Gate - Repair Traces - Yes / (L) Rear Door, Molding - Scratch &amp; Dent - Large / (L) Front Door, Molding - Scratch - Medium / (L) Front Fender, Molding - Scratch - Medium / Front Bumper, Grille, Lamps - Scratch &amp; Dent - Large / Bonnet, Headlight - Scratch - Small / (R) Front Fender, Molding - Scratch - Minimal / (R) Mirror - Scratch - Minimal / (R) Front Door, Molding - Scratch &amp; Dent - Small / (R) Rear Door, Molding - Scratch - Large / (R) Rear Fender, Molding - Scratch - Medium / Trunk Hood, Rear Gate - Scratch - Small / Rear Bumper, Lamps, Panels - Scratch - Medium / Roof - Scratch - Small</p> |

Low battery. Gap at left headlight. more scratch and dent at front bumper. Without warranty booklet, spare tire, jack, tools and seat cover. 1 key. With LTO plate. Different mags.
