## General Information

| Make | Toyota | Model | Vios |
| Registration No. | NHC1564 | Chassis No. | PA1B18F35N4192588 |

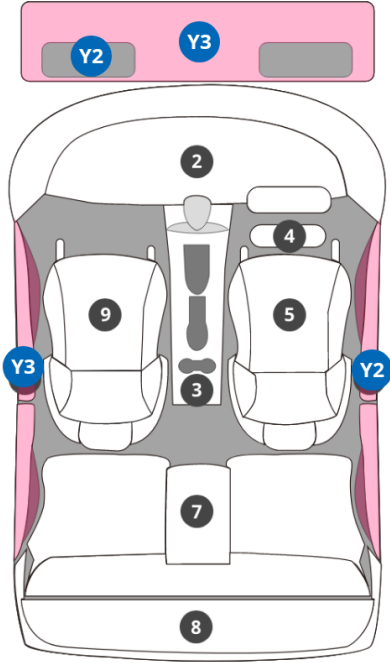
| Interior Evaluation : <b>B</b> | Exterior Evaluation : <b>E</b> |
|---|---|
| <p><b>Remarks</b><br/>Ceiling - Grime - Medium / (R) Front Trim - Grime - Small / (L) Front Trim - Grime - Medium / Sunvisor, Sunglass Holder - Grime - Small</p> | <p><b>Remarks</b><br/>(R) Front Door, Molding - Scratch - Large / (R) Front Fender, Molding - Scratch &amp; Dent - Small / (R) Rear Door, Molding - Scratch - Large / (R) Rear Fender, Molding - Scratch - Large / Rear Bumper, Lamps, Panels - Scratch &amp; Dent - Large / Trunk Hood, Rear Gate - Scratch - Large / (L) Rear Fender, Molding - Scratch - Small / (L) Rear Door, Molding - Scratch - Large / (L) Front Door, Molding - Scratch - Large / (L) Mirror - Scratch - Small / (L) Front Fender, Molding - Scratch &amp; Dent - Large / Front Bumper, Grille, Lamps - Scratch &amp; Dent - Large / Bonnet, Headlight - Scratch - Medium / Roof - Dent - Small</p> |
