## General Information

| Make | Toyota | Model | Vios |
| Registration No. | BAC5273 | Chassis No. | PA1B18F31N4178087 |

## Body / Panel Condition

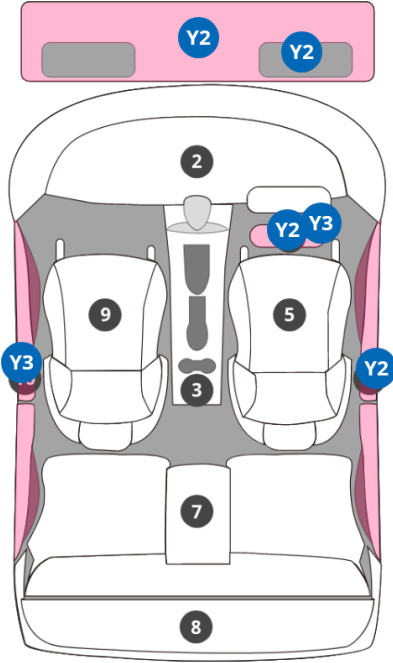
| Interior Evaluation : <b>B</b> | Exterior Evaluation : <b>D</b> |
| <p><b>Remarks</b></p> <p>Ceiling - Grime - Small / (R) Front Trim - Grime - Small / (R) Front Floor Mat - Grime - Medium / Mat Other - Grime - Small / (L) Front Trim - Grime - Medium / Sunvisor, Sunglass Holder - Grime - Small</p> | <p><b>Remarks</b></p> <p>(R) Front Fender - Repair Traces - Yes / Bonnet - Repair Traces - Yes / (L) Front Fender - Repair Traces - Yes / Trunk Hood, Rear Gate - Repair Traces - Yes / (R) Rear Fender, Molding - Scratch &amp; Dent - Medium / (R) Rear Door, Molding - Scratch - Large / (R) Front Door, Molding - Scratch - Large / (R) Step, In-panel, Side Spoiler - Scratch &amp; Dent - Large / (L) Mirror - Scratch - Minimal / Front Bumper, Grille, Lamps - Scratch &amp; Dent - Small / (L) Rear Fender, Molding - Dent - Minimal / (L) Rear Door, Molding - Scratch - Minimal / Trunk Hood, Rear Gate - Scratch - Small / Rear Bumper, Lamps, Panels - Scratch &amp; Dent - Medium / Roof - Dent - Small / (L) Front Door, Molding - Scratch &amp; Dent - Minimal</p> |
