## General Information

| Make | Suzuki | Model | Ciaz |
| YOM | 2019 | Odo Meter Reading | 47,532 |
| Registration No. | NFW2062 | Chassis No. | MMSVCC41S5KR104710 |

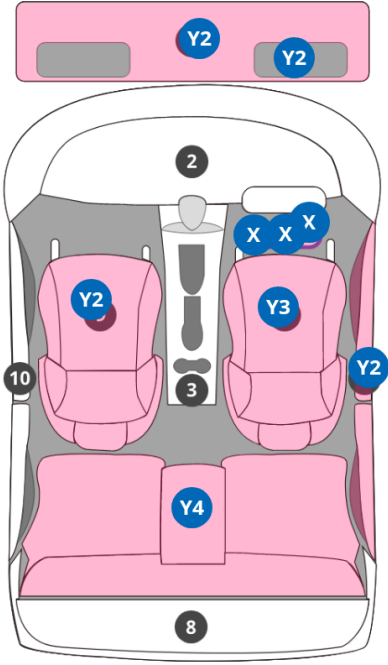
| Interior Evaluation : <span style="color: red;">C</span> | Exterior Evaluation : <span style="color: red;">C</span> |
|---|---|
| <b>Remarks</b><br>(R) Front Floor Mat - Missing - Yes / Mat Other - Missing - Yes / (L) Front Floor Mat - Missing - Yes / Ceiling - Grime - Small / (R) Front Trim - Grime - Small / (R) Front Seat - Grime - Medium / Rear Seat - Grime - Large / (L) Front Seat - Grime - Small / Sunvisor, Sunglass Holder - Grime - Small | <b>Remarks</b><br>(L) Front Fender - Repair Traces - Yes / Front Bumper, Grille, Lamps - Scratch & Dent - Large / (R) Mirror - Scratch - Minimal / (R) Rear Fender, Molding - Scratch - Small / (R) Front Door, Molding - Scratch - Small / (R) Rear Door, Molding - Scratch - Small / Trunk Hood, Rear Gate - Scratch & Dent - Small / (L) Rear Fender, Molding - Scratch - Small / Rear Bumper, Lamps, Panels - Scratch - Small / (L) Rear Door, Molding - Scratch - Medium / (L) Front Door, Molding - Scratch - Small / (L) Mirror - Scratch - Minimal / (L) Front Fender, Molding - Scratch - Small |
