## General Information

| Make | Toyota | Model | Avanza |
| YOM | 2023 | Odo Meter Reading | 112,607 |
| Registration No. | NIJ9183 | Chassis No. | MHFAA1BY5P0012153 |

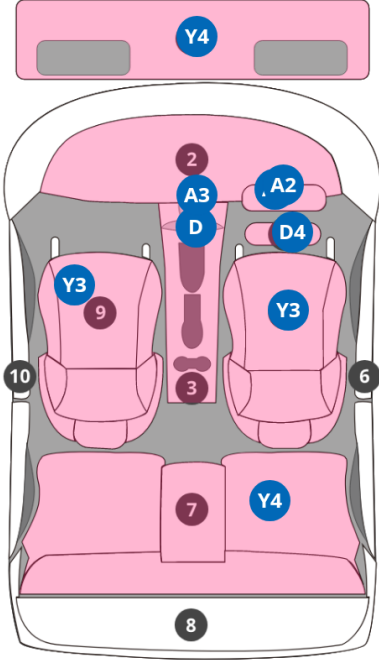
| Interior Evaluation : <b>D</b> | Exterior Evaluation : <b>E</b> |
| <p><b>Remarks</b></p> <p>Overall Interior - Worn as per age - Yes / (R) Front Seat - Grime - Medium / Console, Switchs, Vents - Traces of Adhesive Tape - Yes / Rear Seat - Grime - Large / Glove Box - Worn, Scratch, Cut, Crack - Small / Steering Wheel - Worn, Peel, Crack - Small / (L) Front Seat - Grime - Medium / (L) Front Floor Mat - Worked - Large / Console, Switchs, Vents - Worn, Scratch, Cut, Crack - Medium / Ceiling - Grime - Large</p> | <p><b>Remarks</b></p> <p>Bonnet - Repair Traces - Yes / (L) Rear Fender - Repair Traces - Yes / (L) Rear Fender, Molding - Repair mark - Yes / Bonnet, Headlight - Repair mark - Yes / (R) Front Fender, Molding - Scratch - Small / (R) Front Door, Molding - Scratch - Small / (R) Rear Door, Molding - Scratch - Medium / (R) Mirror - Scratch - Small / (R) Rear Fender, Molding - Scratch - Minimal / Rear Bumper, Lamps, Panels - Scratch - Medium / Trunk Hood, Rear Gate - Scratch - Small / (L) Rear Fender, Molding - Scratch - Small / (L) Mirror - Scratch - Small / (L) Rear Door, Molding - Scratch &amp; Dent - Large / (L) Front Door, Molding - Scratch - Medium / (L) Front Fender, Molding - Scratch &amp; Dent - Large / Front Bumper, Grille, Lamps - Crack, Gap - Large / Member (Bolted) - Dent - Yes / Bonnet, Headlight - Dent - Large / Roof - Dent - Small</p> |
