## General Information

| Make | Toyota | Model | Vios |
| YOM | 2024 | Odo Meter Reading | 25,400 |
| Registration No. | NHF9121 | Chassis No. | PA1B18F35P4234101 |

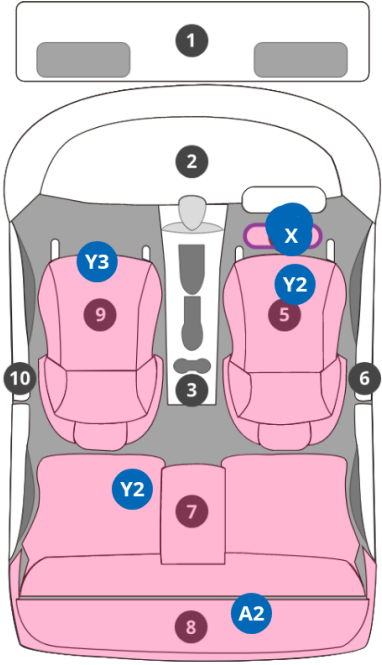
| Interior Evaluation : <b>B</b> | Exterior Evaluation : <b>E</b> |
| <p><b>Remarks</b></p> <p>Trunk Room - Worn, Scratch, Cut, Crack - Small / (R)<br/>Front Floor Mat - Missing - Yes / (L) Front Floor Mat - Missing - Yes / Mat Other - Missing - Yes / Rear Seat - Grime - Small / (L) Front Seat - Grime - Medium / (R) Front Seat - Grime - Small</p> | <p><b>Remarks</b></p> <p>(R) Front Fender - Repair Traces - Yes / (L) Front Fender - Repair Traces - Yes / (L) Rear Fender - Repair Traces - Yes / Trunk Hood, Rear Gate - Repair Traces - Yes / Trunk Hood, Rear Gate - Repair mark - Yes / Rear Bumper, Lamps, Panels - Repair mark - Yes / (L) Rear Fender, Molding - Repair mark - Yes / (L) Rear Door, Molding - Repair mark - Yes / (L) Front Fender, Molding - Repair mark - Yes / (R) Front Fender, Molding - Repair mark - Yes / (R) Front Fender, Molding - Scratch - Minimal / (R) Mirror - Scratch - Small / (R) Front Door, Molding - Scratch - Medium / (R) Rear Door, Molding - Scratch - Medium / (R) Rear Fender, Molding - Scratch - Small / Rear Bumper, Lamps, Panels - Crack, Gap - Large / Trunk Hood, Rear Gate - Scratch - Small / (L) Rear Fender, Molding - Scratch - Small / (L) Rear Door, Molding - Scratch - Medium / (L) Step, In-panel, Side Spoiler - Scratch - Small / (L) Mirror - Crack - Damaged / (L) Front Door, Molding - Scratch - Minimal / (L) Front Fender, Molding - Scratch - Small / Front Bumper, Grille, Lamps - Repair mark - Yes / Front Bumper, Grille, Lamps - Scratch &amp; Dent - Medium / Roof - Dent - Small / Bonnet, Headlight - Scratch - Minimal</p> |

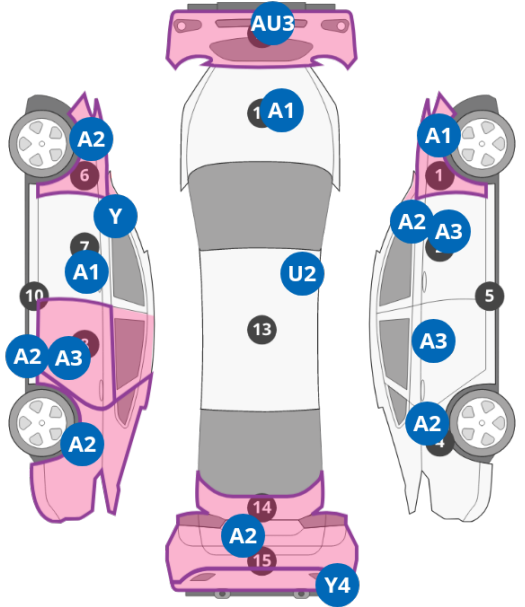
| Inspector Notes |
|---|
| with LTO plate, no warranty booklet, no jack and tools, no spare tire, damaged rear bumper, missing right tail light, damaged headlight, battery weak, trunk hood issue |
