## General Information

| Make | Toyota | Model | Fortuner |
| Registration No. | TBQ207 | Chassis No. | MHFYZ59G504001437 |

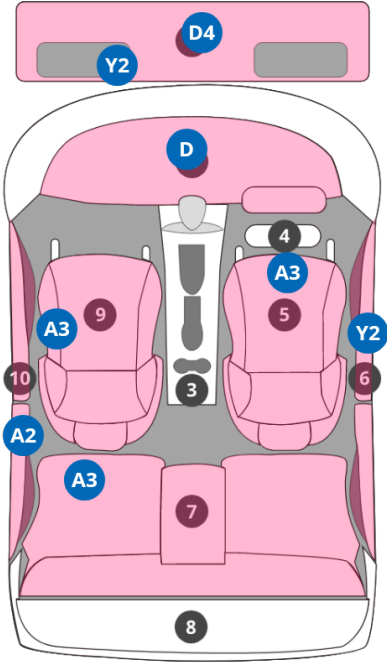
| Interior Evaluation : <span style="color: red;">C</span> | Exterior Evaluation : <span style="color: red;">C</span> |
| <p><b>Remarks</b></p> <p>Overall Interior - Worn as per age - Yes / (L) Front Seat - Cut, Crack - Medium / (R) Front Seat - Cut, Crack - Medium / (R) Front Trim - Grime - Small / (L) Front Trim - Cut, Crack - Small / Rear Seat - Cut, Crack - Medium / Sunvisor, Sunglass Holder - Grime - Small / Ceiling - Crinkle - Large / Dashboard - Traces of Adhesive Tape - Yes</p> | <p><b>Remarks</b></p> <p>(R) Front Fender - Repair Traces - Yes / Bonnet - Repair Traces - Yes / (L) Front Fender - Repair Traces - Yes / (L) Rear Fender - Repair Traces - Yes / Trunk Hood, Rear Gate - Repair Traces - Yes / (R) Rear Fender - Repair Traces - Yes / Roof - Repair Traces - Yes / Overall Exterior - Worn as per age - Yes / (R) Mirror - Scratch - Small / (R) Front Fender, Molding - Scratch - Small / (R) Step, In-panel, Side Spoiler - Scratch &amp; Dent - Small / (R) Front Door, Molding - Scratch - Small / (R) Rear Door, Molding - Scratch - Small / (R) Rear Fender, Molding - Scratch - Small / Rear Bumper, Lamps, Panels - Scratch - Medium / Trunk Hood, Rear Gate - Dent - Small / (L) Rear Fender, Molding - Scratch - Minimal / (L) Rear Door, Molding - Scratch - Minimal / (L) Front Door, Molding - Scratch - Minimal / (L) Mirror - Scratch - Minimal / (L) Front Fender, Molding - Scratch - Small / Front Bumper, Grille, Lamps - Crack, Gap - Medium / Bonnet, Headlight - Scratch - Minimal / Roof - Modified - Small / Roof - Scratch - Minimal</p> |
