General Information

| Make | Toyota | Model | Vios |
| Registration No. | NHM2862 | Chassis No. | PA1B18F3XR4240950 |

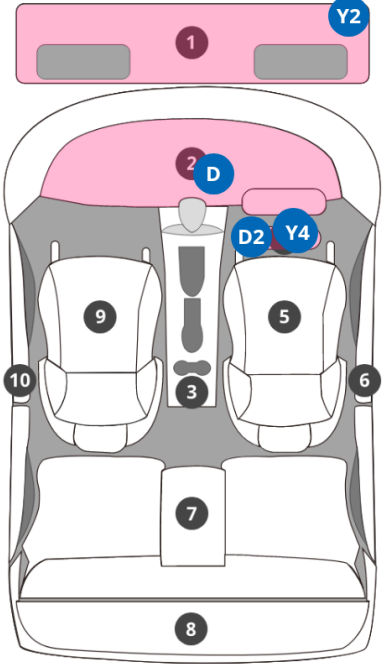
| Interior Evaluation : C | Exterior Evaluation : B |
| <p>Remarks (L) Front Floor Mat - Worked - Small / (R) Front Floor Mat - Grime - Medium / Mat Other - Grime - Large / Dashboard - Traces of Adhesive Tape - Yes / Ceiling - Grime - Small</p> | <p>Remarks Bonnet - Repair Traces - Yes / (L) Rear Door, Molding - Scratch & Dent - Small / Front Bumper, Grille, Lamps - Scratch - Medium / Rear Bumper, Lamps, Panels - Scratch - Medium / (R) Rear Fender, Molding - Scratch - Small / (R) Front Door, Molding - Dent - Small / (L) Front Door, Molding - Scratch & Dent - Small / Bonnet, Headlight - Repair mark - Yes</p> |
