## General Information

| Make | Toyota | Model | Vios |
| Registration No. | NIE9625 | Chassis No. | PA1B18F32N4187445 |

## Body / Panel Condition

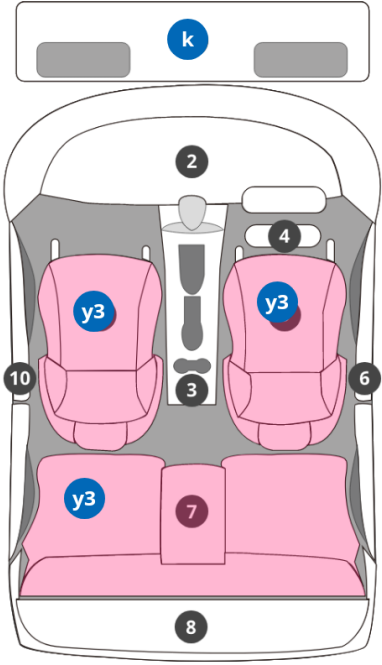
| Interior Evaluation : <b>B</b> | Exterior Evaluation : <b>B</b> |
|---|---|
| <b>Remarks</b><br>(L) Front Seat - Grime - Medium / Overall Interior - Animal Hair - Yes / Rear Seat - Grime - Medium / (R) Front Seat - Grime - Medium | <b>Remarks</b><br>Front Bumper, Grille, Lamps - Scratch - Medium / (L) Front Fender, Molding - Scratch - Minimal / (L) Front Door, Molding - Scratch - Small / Rear Bumper, Lamps, Panels - Dent - Minimal / (R) Front Fender, Molding - Dent - Small |

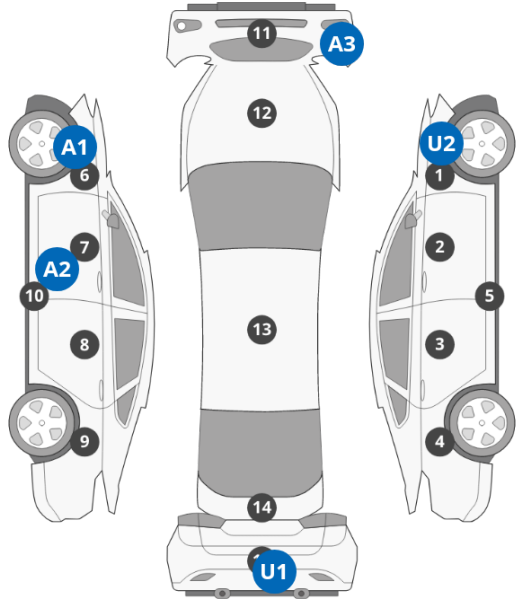
hairline scratches around the exterior. without spare tire and tools. without user manual and warranty booklet
