## General Information

| Make | Toyota | Model | Wigo |
| YOM | 2024 | Odo Meter Reading | 64,564 |
| Registration No. | CCC1098 | Chassis No. | MHKAA1BC9PJ005304 |

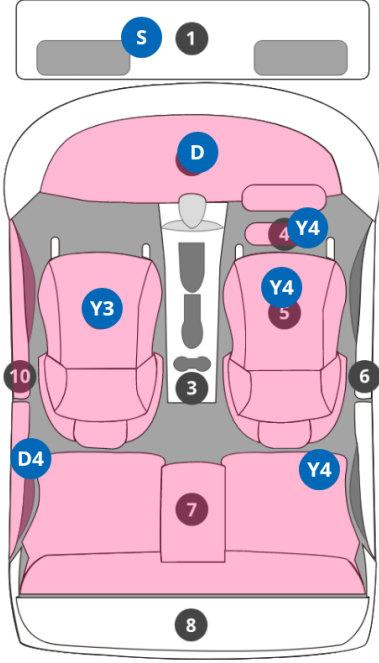
| Interior Evaluation : <b>C</b> | Exterior Evaluation : <b>E</b> |
|---|---|
| <p><b>Remarks</b></p> <p>Overall Interior - Worn as per age - Yes / Dashboard - Traces of Adhesive Tape - Yes / Mat Other - Grime - Large / Overall Interior - Smell - Yes / (L) Front Seat - Grime - Medium / (R) Front Seat - Grime - Large / Rear Seat - Grime - Large / Trim Other - Worked - Large</p> | <p><b>Remarks</b></p> <p>(R) Front Door - Repair Traces - Yes / (R) Step - Repair Traces - Yes / (R) Front Fender - Repair Traces - Yes / Bonnet - Repair Traces - Yes / (L) Front Fender - Repair Traces - Yes / (L) Front Door - Repair Traces - Yes / (L) Step - Repair Traces - Yes / (L) Rear Fender - Repair Traces - Yes / Trunk Hood, Rear Gate - Repair Traces - Yes / (R) Rear Fender - Repair Traces - Yes / (R) Rear Door - Repair Traces - Yes / Roof - Repair Traces - Yes / Front Bumper, Grille, Lamps - Scratch &amp; Dent - Large / Member (Bolted) - Dent - Yes / Bonnet, Headlight - Scratch &amp; Dent - Large / (L) Front Fender, Molding - Dent - Large / (L) Mirror - Scratch - Small / (L) Front Door, Molding - Scratch - Small / (L) Step, In-panel, Side Spoiler - Scratch - Small / (L) Rear Door, Molding - Scratch - Small / (L) Rear Fender, Molding - Scratch - Small / Rear Bumper, Lamps, Panels - Scratch - Large / Trunk Hood, Rear Gate - Scratch - Small / (R) Rear Fender, Molding - Scratch &amp; Dent - Medium / (R) Rear Door, Molding - Scratch &amp; Dent - Medium / (R) Step, In-panel, Side Spoiler - Scratch &amp; Dent - Medium / (R) Front Door, Molding - Scratch - Small / (R) Front Fender, Molding - Scratch - Small</p> |
