## General Information

Date & Time: 11, Aug, 2025 13:36

<b>Make</b>	Toyota	<b>Model</b>	Rush
<b>YOM</b>	2024	<b>Odo Meter Reading</b>	26,413
<b>Registration No.</b>	DBP1612	<b>Chassis No.</b>	MHKE8FF3PRK061827
<b>CC</b>	1.5	<b>Transmission</b>	A/T
<b>Fuel Type</b>	Gas	<b>Type of Body</b>	SUV
<b>Colour</b>	Black

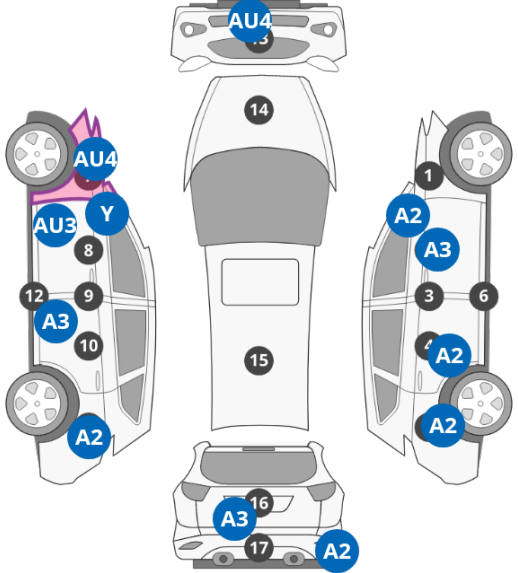
<p><b>A</b> : Scratch <b>AU</b> : Scratch &amp; Dent <b>B</b> : Modified <b>C</b> : Corrosion <b>G</b> : Stone chip <b>P</b> : Faded <b>S</b> : Rust <b>SC</b> : Rust &amp; Corrosion <b>U</b> : Dent <b>X</b> : Defective <b>Y</b> : Crack, Gap</p>
<p><b>Remarks</b>          Ceiling - Grime - Small / (R) Front Trim - Grime - Small / (R) Front Floor Mat - Grime - Small / (R) Front Seat - Grime - Small / Rear Seat - Grime - Medium / Mat Other - Crinkle - Medium / (L) Rear Trim - Grime - Minimal / (L) Front Trim - Grime - Medium / (L) Front Floor Mat - Worked - Small / Dashboard - Traces of Adhesive Tape - Yes</p>	<p><b>Remarks</b>          Front Bumper, Grille, Lamps - Scratch &amp; Dent - Large / (R) Mirror - Scratch - Small / (R) Front Door, Molding - Scratch - Medium / (R) Rear Door, Molding - Scratch - Small / (R) Rear Fender, Molding - Scratch - Small / Trunk Hood, Rear Gate - Scratch - Medium / (L) Rear Fender, Molding - Scratch - Small / Rear Bumper, Lamps, Panels - Scratch - Small / (L) Rear Door, Molding - Scratch - Medium / (L) Front Fender, Molding - Scratch &amp; Dent - Large / (L) Front Fender, Molding - Repair mark - Yes / (L) Front Door, Molding - Scratch &amp; Dent - Medium / (L) Mirror - Crack - Damaged</p>

<b>Inspector Notes</b>
Damaged left side mirror. Without warranty booklet and tools. With spare tire,jack and seat cover. 1 key. With LTO plate.
