General Information

Date & Time: 07, Aug, 2025 15:50

Make	Toyota	Model	Wigo
YOM	2023	Odo Meter Reading	22,141
Registration No.	EAF5468	Chassis No.	MHKA4DE5FNJ017786
CC	1.0	Transmission	M/T
Fuel Type	Gas	Type of Body	Hatchback
Colour	Black

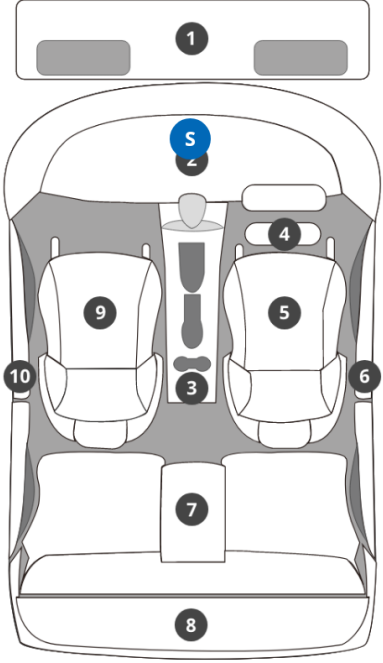
<p>a : Cut, Fray d : Loose, Deformed k : Animal Hair s : Smell t : Cigarette Burns x : Defective y : Stain</p>

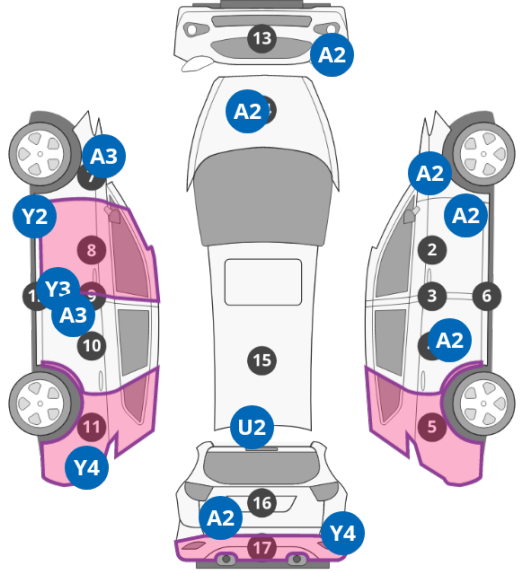
<p>A : Scratch AU : Scratch & Dent B : Modified C : Corrosion G : Stone chip P : Faded S : Rust SC : Rust & Corrosion U : Dent X : Defective Y : Crack, Gap</p>
Remarks Overall Interior - Smell - Yes	Remarks (R) Step - Repair Traces - Yes / (R) Front Fender - Repair Traces - Yes / Bonnet - Repair Traces - Yes / (L) Front Fender - Repair Traces - Yes / (L) Front Door - Repair Traces - Yes / (L) Step - Repair Traces - Yes / (L) Rear Door - Repair Traces - Yes / (R) Rear Fender - Repair Traces - Yes / (R) Rear Door - Repair Traces - Yes / (R) Rear Fender, Molding - Repair mark - Yes / Rear Bumper, Lamps, Panels - Repair mark - Yes / (L) Rear Fender, Molding - Repair mark - Yes / (L) Front Door, Molding - Repair mark - Yes / (L) Front Fender, Molding - Scratch - Medium / (L) Front Door, Molding - Crack, Gap - Medium / (L) Step, In-panel, Side Spoiler - Crack, Gap - Small / (L) Rear Door, Molding - Scratch - Medium / (L) Rear Fender, Molding - Crack, Gap - Large / Rear Bumper, Lamps, Panels - Crack, Gap - Large / Roof - Dent - Small / Trunk Hood, Rear Gate - Scratch - Small / (R) Rear Door, Molding - Scratch - Small / (R) Front Door, Molding - Scratch - Small / (R) Front Fender, Molding - Scratch - Small / Front Bumper, Grille, Lamps - Scratch - Small / Bonnet, Headlight - Scratch - Small
