## General Information

| Make | Toyota | Model | Hiace |
| Registration No. | NDN5609 | Chassis No. | JTFJT02P4K5021999 |

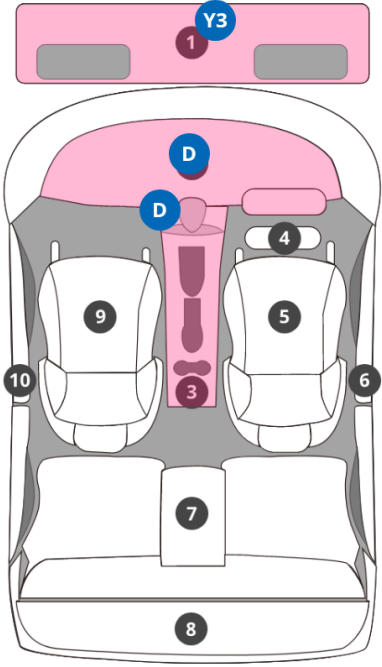
| Interior Evaluation : <b>C</b> | Exterior Evaluation : <b>E</b> |
|---|---|
| <p><b>Remarks</b></p> <p>Overall Interior - Worn as per age - Yes / Ceiling - Grime - Medium / Dashboard - Traces of Adhesive Tape - Yes / Console, Switchs, Vents - Traces of Adhesive Tape - Yes</p> | <p><b>Remarks</b></p> <p>Trunk Hood, Rear Gate - Repair Traces - Yes / (R) Rear Door, Molding - Repair mark - Yes / (R) Rear Fender, Molding - Repair mark - Yes / (R) Front Door, Molding - Scratch - Medium / (R) Rear Door, Molding - Scratch - Large / (R) Rear Fender, Molding - Scratch - Medium / Rear Bumper, Lamps, Panels - Scratch - Medium / Trunk Hood, Rear Gate - Scratch - Medium / (L) Rear Fender, Molding - Scratch &amp; Dent - Medium / (L) Rear Door, Molding - Scratch - Small / (L) Front Door, Molding - Scratch &amp; Dent - Medium / (L) Front Fender, Molding - Scratch - Small / (R) Front Fender, Molding - Dent - Medium / Front Bumper, Grille, Lamps - Scratch &amp; Dent - Medium / Roof - Scratch - Minimal</p> |
