## General Information

| Make | Toyota | Model | Hiace |
| Registration No. | NIK5091 | Chassis No. | JTFJT02PXP5033971 |

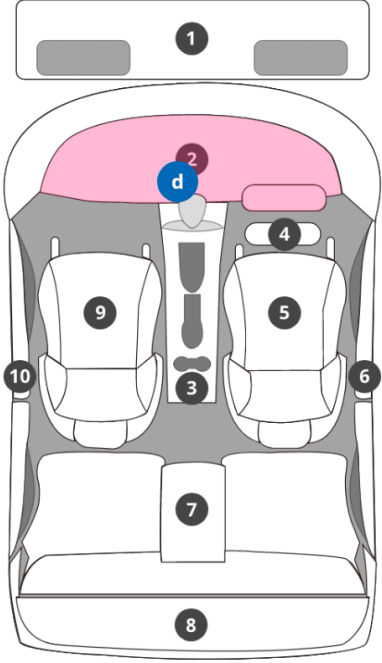
| <b>Remarks</b><br>Dashboard - Traces of Adhesive Tape - Yes / Overall Interior - Worn as per age - Yes | <b>Remarks</b><br>Bonnet - Repair Traces - Yes / (L) Front Door - Repair Traces - Yes / (L) Rear Fender - Repair Traces - Yes / (R) Rear Fender - Repair Traces - Yes / Trunk Hood, Rear Gate - Modified - Medium / Roof - Modified - Large / (L) Rear Fender, Molding - Dent - Small / (L) Rear Door, Molding - Dent - Small / Front Bumper, Grille, Lamps - Scratch - Medium / Rear Bumper, Lamps, Panels - Scratch - Large / (R) Rear Wheel, Cover - Cap Missing - Yes / (R) Front Wheel, Cover - Cap Missing - Yes / (L) Rear Wheel, Cover - Cap Missing - Yes / (L) Front Wheel, Cover - Cap Missing - Yes |
