## General Information

| Make | Toyota | Model | Innova |
| Registration No. | DAR7944 | Chassis No. | PA2JA8EM9N0111701 |

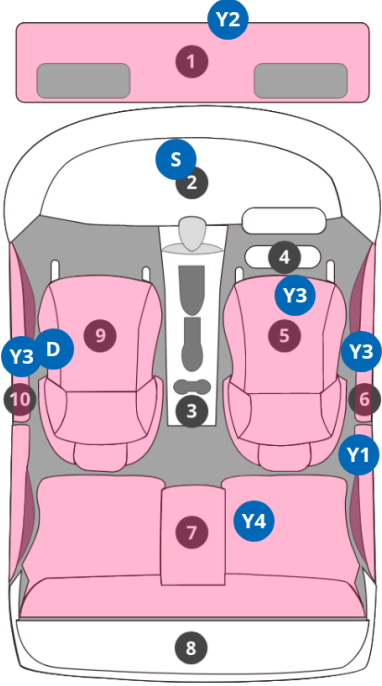
| Interior Evaluation : <b>C</b> | Exterior Evaluation : <b>E</b> |
| <p><b>Remarks</b><br/>(R) Front Seat - Grime - Medium / Rear Seat - Grime - Large / (L) Front Seat - Worn - Yes / Overall Interior - Smell - Yes / (R) Rear Trim - Grime - Minimal / (R) Front Trim - Grime - Medium / (L) Front Trim - Grime - Medium / Ceiling - Grime - Small</p> | <p><b>Remarks</b><br/>Bonnet - Repair Traces - Yes / (R) Front Fender, Molding - Scratch - Minimal / (R) Front Door, Molding - Scratch &amp; Dent - Large / (R) Rear Door, Molding - Repair mark - Difference in Color / (R) Rear Door, Molding - Scratch &amp; Dent - Medium / (R) Rear Fender, Molding - Scratch - Small / Trunk Hood, Rear Gate - Scratch &amp; Dent - Small / Rear Bumper, Lamps, Panels - Scratch - Small / (L) Rear Fender, Molding - Scratch &amp; Dent - Medium / (L) Front Door, Molding - Dent - Medium / (L) Rear Door, Molding - Scratch - Medium / (L) Mirror - Scratch - Small / (L) Front Fender, Molding - Scratch - Small / Front Bumper, Grille, Lamps - Scratch - Medium / Bonnet, Headlight - Scratch - Small / (R) Mirror - Scratch - Minimal / Roof - Scratch - Minimal</p> |
