## General Information

| Make | Toyota | Model | Vios |
| Registration No. | NHA2068 | Chassis No. | PA1B18F31P4219336 |

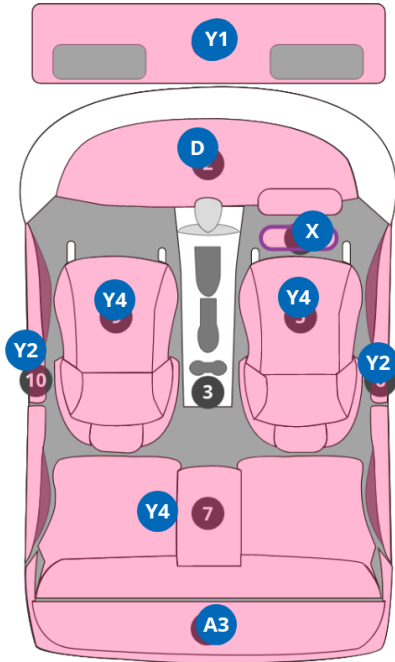
| Interior Evaluation : <b>C</b> | Exterior Evaluation : <b>E</b> |
|---|---|
| <p><b>Remarks</b></p> <p>Trunk Room - Worn, Scratch, Cut, Crack - Medium / Rear Seat - Grime - Large / Overall Interior - Smell - Yes / (L) Front Floor Mat - Missing - Yes / (L) Front Trim - Grime - Small / Overall Interior - Worn as per age - Yes / (R) Front Seat - Grime - Large / (R) Front Trim - Grime - Small / (L) Front Seat - Grime - Large / Dashboard - Traces of Adhesive Tape - Yes / Ceiling - Grime - Minimal</p> | <p><b>Remarks</b></p> <p>(L) Rear Fender - Repair Traces - Yes / (R) Rear Fender - Repair Traces - Yes / (R) Front Fender, Molding - Dent - Large / (R) Mirror - Scratch - Small / (R) Front Door, Molding - Scratch - Small / (R) Rear Door, Molding - Repair mark - Yes / Overall Exterior - Faded(Color, Gloss) - Yes / (R) Rear Fender, Molding - Repair mark - Yes / (L) Rear Fender, Molding - Repair mark - Yes / (R) Rear Door, Molding - Scratch - Small / (R) Rear Fender, Molding - Scratch - Small / Rear Bumper, Lamps, Panels - Repair mark - Yes / Rear Bumper, Lamps, Panels - Scratch - Medium / (L) Rear Door, Molding - Repair mark - Yes / Trunk Hood, Rear Gate - Dent - Medium / (L) Rear Fender, Molding - Scratch - Small / (L) Rear Door, Molding - Scratch - Small / (L) Front Door, Molding - Scratch - Small / (L) Front Fender, Molding - Scratch - Small / Front Bumper, Grille, Lamps - Crack, Gap - Large / Bonnet, Headlight - Scratch &amp; Dent - Small / Roof - Scratch - Minimal</p> |
