## General Information

| Make | Toyota | Model | Vios |
| Registration No. | DBO6959 | Chassis No. | PA1B18F3XR4256243 |

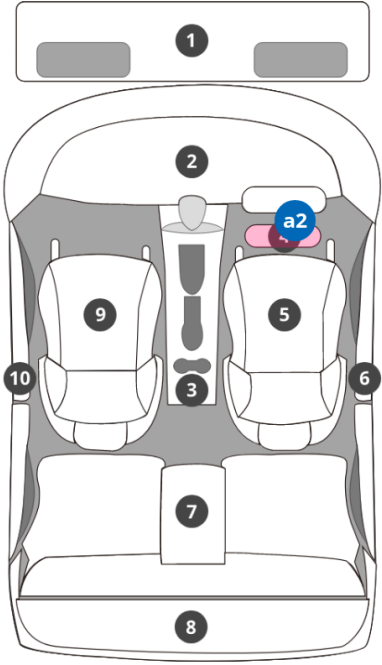
| Interior Evaluation : <span style="color: red;">A</span> | Exterior Evaluation : <span style="color: red;">C</span> |
|---|---|
| <b>Remarks</b><br>(L) Front Floor Mat - Cut, Crack - Small | <b>Remarks</b><br>(L) Front Fender - Repair Traces - Yes / (L) Front Fender, Molding - Scratch & Dent - Large / Front Bumper, Grille, Lamps - Scratch & Dent - Small / (L) Front Door, Molding - Scratch - Small / (L) Step, In-panel, Side Spoiler - Scratch - Medium / (L) Rear Door, Molding - Scratch - Small / (L) Rear Fender, Molding - Scratch - Minimal / Rear Bumper, Lamps, Panels - Dent - Minimal / (R) Rear Door, Molding - Scratch - Small / (R) Front Door, Molding - Scratch - Medium |
