## General Information

<b>Make</b>	Toyota	<b>Model</b>	Vios
<b>YOM</b>	2024	<b>Odo Meter Reading</b>	33,590
<b>Registration No.</b>	DBN9445	<b>Chassis No.</b>	PA1B18F36P4236732
<b>CC</b>	1.3	<b>Transmission</b>	CVT
<b>Fuel Type</b>	Gas	<b>Type of Body</b>	Sedan
<b>Colour</b>	White

## Body / Panel Condition

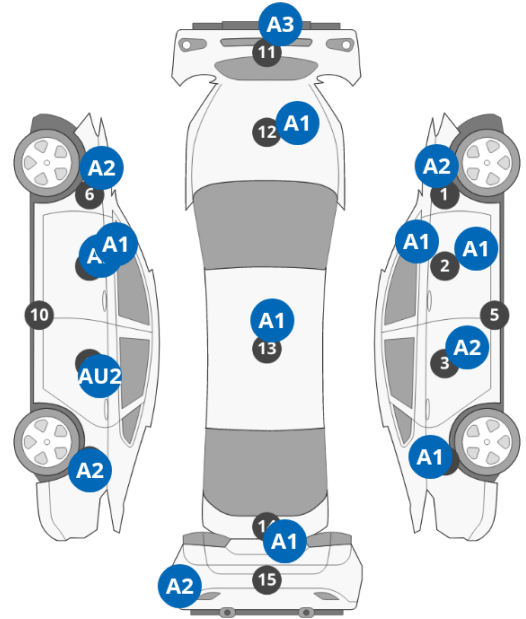
<p><b>A</b> : Scratch <b>AU</b> : Scratch &amp; Dent <b>B</b> : Modified <b>C</b> : Corrosion <b>G</b> : Stone chip <b>P</b> : Faded <b>S</b> : Rust <b>SC</b> : Rust &amp; Corrosion <b>U</b> : Dent <b>X</b> : Defective <b>Y</b> : Crack, Gap</p>
<p><b>Remarks</b>          Trunk Room - Worn, Scratch, Cut, Crack - Small / Rear Seat - Grime - Large / Ceiling - Grime - Small / (R) Front Seat - Grime - Medium / (L) Front Seat - Grime - Medium / (L) Front Trim - Grime - Small</p>	<p><b>Remarks</b>          (R) Front Fender, Molding - Scratch - Small / (R) Front Door, Molding - Scratch - Minimal / (R) Mirror - Scratch - Minimal / (R) Rear Door, Molding - Scratch - Small / (R) Rear Fender, Molding - Scratch - Minimal / Rear Bumper, Lamps, Panels - Scratch - Small / Trunk Hood, Rear Gate - Scratch - Minimal / (L) Rear Fender, Molding - Scratch - Small / (L) Rear Door, Molding - Scratch &amp; Dent - Small / (L) Front Door, Molding - Scratch - Medium / (L) Mirror - Scratch - Minimal / (L) Front Fender, Molding - Scratch - Small / Roof - Scratch - Minimal / Bonnet, Headlight - Scratch - Minimal / Front Bumper, Grille, Lamps - Scratch - Medium</p>
