## General Information

<b>Make</b>	Toyota	<b>Model</b>	Vios
<b>YOM</b>	2024	<b>Odo Meter Reading</b>	18,751
<b>Registration No.</b>	NHM2768	<b>Chassis No.</b>	PA1B18F39R4238977
<b>CC</b>	1.3	<b>Transmission</b>	CVT
<b>Fuel Type</b>	Gas	<b>Type of Body</b>	Sedan
<b>Colour</b>	Red

## Body / Panel Condition

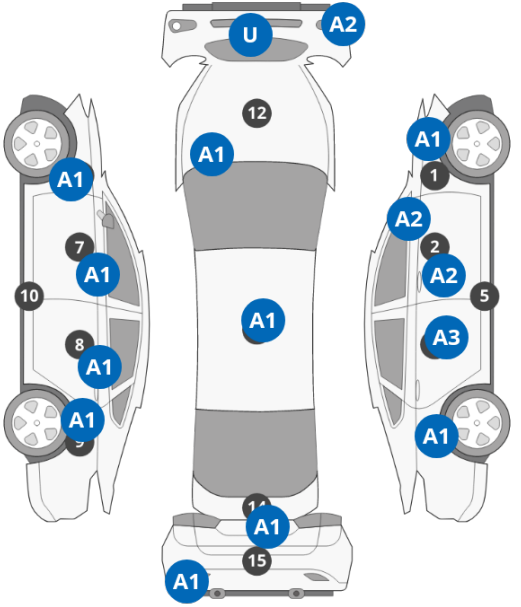
<p><b>A</b> : Scratch <b>AU</b> : Scratch &amp; Dent <b>B</b> : Modified <b>C</b> : Corrosion <b>G</b> : Stone chip <b>P</b> : Faded <b>S</b> : Rust <b>SC</b> : Rust &amp; Corrosion <b>U</b> : Dent <b>X</b> : Defective <b>Y</b> : Crack, Gap</p>
<p><b>Remarks</b> Rear Seat - Grime - Small / (R) Front Seat - Grime - Minimal</p>	<p><b>Remarks</b> Member (Bolted) - Dent - Yes / (R) Front Fender, Molding - Scratch - Minimal / (R) Mirror - Scratch - Small / (R) Front Door, Molding - Scratch - Small / (R) Rear Door, Molding - Scratch - Medium / (R) Rear Fender, Molding - Scratch - Minimal / Rear Bumper, Lamps, Panels - Scratch - Minimal / Trunk Hood, Rear Gate - Scratch - Minimal / (L) Rear Fender, Molding - Scratch - Minimal / (L) Rear Door, Molding - Scratch - Minimal / (L) Front Door, Molding - Scratch - Minimal / (L) Front Fender, Molding - Scratch - Minimal / Front Bumper, Grille, Lamps - Scratch - Small / Roof - Scratch - Minimal / Bonnet, Headlight - Scratch - Minimal</p>
