## General Information

| Make | Toyota | Model | Avanza |
| Registration No. | NGS4665 | Chassis No. | MHKM5EF2FLK027700 |

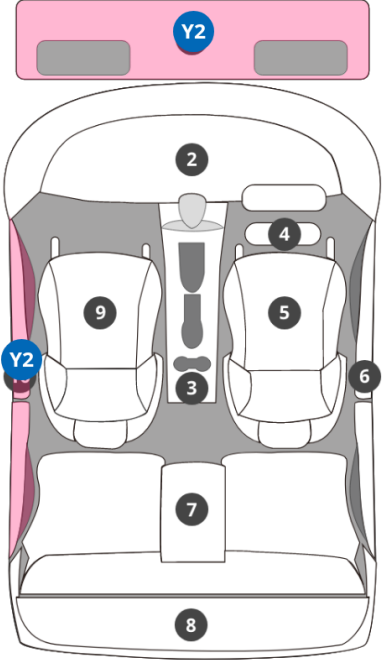
| Interior Evaluation : <b>A</b> | Exterior Evaluation : <b>E</b> |
| <b>Remarks</b><br>Ceiling - Grime - Small / (L) Front Trim - Grime - Small | <b>Remarks</b><br>Bonnet - Repair Traces - Yes / (L) Front Door - Repair Traces - Yes / (L) Rear Door - Repair Traces - Yes / Trunk Hood, Rear Gate - Repair Traces - Yes / (L) Mirror - Scratch - Medium / (L) Step, In-panel, Side Spoiler - Scratch - Small / (L) Front Door, Molding - Scratch - Minimal / (L) Rear Door, Molding - Scratch - Small / (L) Rear Fender, Molding - Scratch - Medium / Rear Bumper, Lamps, Panels - Scratch & Dent - Medium / (R) Front Door, Molding - Scratch - Large / (R) Rear Door, Molding - Scratch - Medium / (R) Rear Fender, Molding - Scratch - Medium / (R) Mirror - Scratch - Minimal / Front Bumper, Grille, Lamps - Scratch & Dent - Large / Roof - Dent - Small |
