## General Information

Date & Time: 12, Aug, 2025 13:47

<b>Make</b>	Toyota	<b>Model</b>	Vios
<b>YOM</b>	2021	<b>Odo Meter Reading</b>	111,575
<b>Registration No.</b>	DAP3280	<b>Chassis No.</b>	PA1B18F30M4156533
<b>CC</b>	1.3	<b>Transmission</b>	CVT
<b>Fuel Type</b>	Gas	<b>Type of Body</b>	Sedan
<b>Colour</b>	Red Mica Metallic

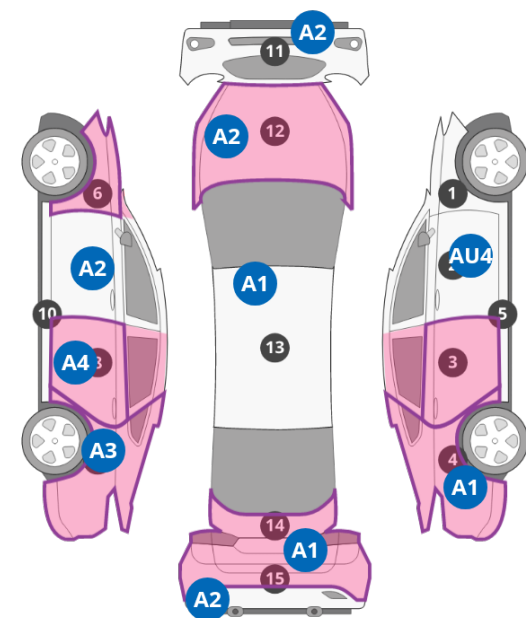
<p><b>A</b> : Scratch <b>AU</b> : Scratch &amp; Dent <b>B</b> : Modified <b>C</b> : Corrosion <b>G</b> : Stone chip <b>P</b> : Faded <b>S</b> : Rust <b>SC</b> : Rust &amp; Corrosion <b>U</b> : Dent <b>X</b> : Defective <b>Y</b> : Crack, Gap</p>
<p><b>Remarks</b> Trunk Room - Worn, Scratch, Cut, Crack - Medium / Rear Seat - Cut, Crack - Small / (R) Front Seat - Grime - Small / (R) Front Trim - Grime - Medium / (L) Front Trim - Grime - Medium / Ceiling - Grime - Medium / (L) Rear Trim - Grime - Small</p>	<p><b>Remarks</b> (R) Front Fender - Repair Traces - Yes / (L) Front Fender - Repair Traces - Yes / (L) Front Door - Repair Traces - Yes / (L) Rear Door - Repair Traces - Yes / (L) Rear Fender - Repair Traces - Yes / Trunk Hood, Rear Gate - Repair Traces - Yes / Roof - Repair Traces - Yes / Rear Bumper, Lamps, Panels - Scratch - Small / Trunk Hood, Rear Gate - Repair mark - Yes / (L) Rear Door, Molding - Repair mark - Yes / Bonnet, Headlight - Repair mark - Yes / (R) Rear Fender, Molding - Repair mark - Yes / (L) Rear Fender, Molding - Repair mark - Yes / (R) Rear Door, Molding - Repair mark - Yes / (L) Front Fender, Molding - Repair mark - Yes / (R) Front Door, Molding - Scratch &amp; Dent - Large / Bonnet, Headlight - Scratch - Small / Front Bumper, Grille, Lamps - Scratch - Small / (L) Front Door, Molding - Scratch - Small / (L) Rear Door, Molding - Scratch - Large / (L) Rear Fender, Molding - Scratch - Medium / (R) Rear Fender, Molding - Scratch - Minimal / Trunk Hood, Rear Gate - Scratch - Minimal / Roof - Scratch - Minimal</p>
