General Information

Date & Time: 12, Aug, 2025 09:43

Make	Toyota	Model	Vios
YOM	2024	Odo Meter Reading	49,219
Registration No.	DBO7347	Chassis No.	PA1B18F33R4255774
CC	1.3	Transmission	CVT
Fuel Type	Gas	Type of Body	Sedan
Colour	Blue

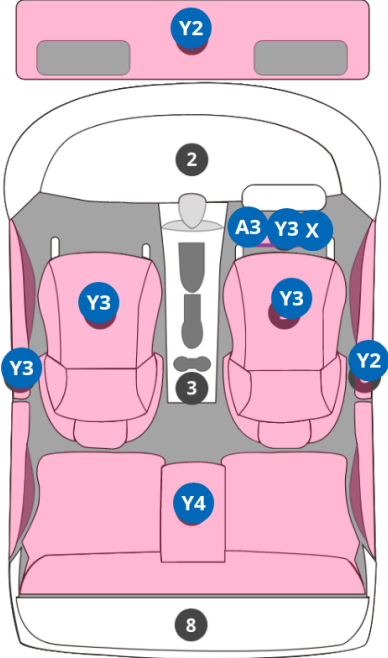
Interior Evaluation : C	Exterior Evaluation : C

<p>a : Cut, Fray d : Loose, Deformed k : Animal Hair s : Smell t : Cigarette Burns x : Defective y : Stain</p>

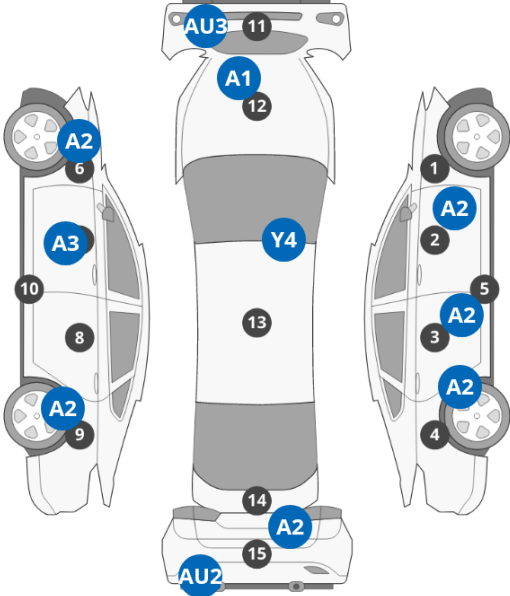
<p>A : Scratch AU : Scratch & Dent B : Modified C : Corrosion G : Stone chip P : Faded S : Rust SC : Rust & Corrosion U : Dent X : Defective Y : Crack, Gap</p>
<p>Remarks Ceiling - Grime - Small / (R) Front Floor Mat - Missing - Yes / (R) Front Trim - Grime - Small / (R) Front Seat - Grime - Medium / Rear Seat - Grime - Large / Mat Other - Grime - Medium / (L) Front Trim - Grime - Medium / (L) Front Seat - Grime - Medium / (L) Front Floor Mat - Cut, Crack - Medium</p>	<p>Remarks (R) Front Door - Repair Traces - Yes / (R) Front Fender - Repair Traces - Yes / Bonnet - Repair Traces - Yes / (L) Front Fender - Repair Traces - Yes / (L) Front Door - Repair Traces - Yes / (L) Rear Door - Repair Traces - Yes / Trunk Hood, Rear Gate - Repair Traces - Yes / (R) Rear Fender - Repair Traces - Yes / (R) Rear Door - Repair Traces - Yes / Roof - Repair Traces - Yes / (L) Front Door, Molding - Scratch - Medium / (L) Rear Fender, Molding - Scratch - Small / (L) Front Fender, Molding - Scratch - Small / (R) Rear Fender, Molding - Scratch - Small / (R) Rear Door, Molding - Scratch - Small / (R) Front Door, Molding - Scratch - Small / Trunk Hood, Rear Gate - Scratch - Small / Rear Bumper, Lamps, Panels - Scratch & Dent - Small / Bonnet, Headlight - Scratch - Minimal / Front Bumper, Grille, Lamps - Scratch & Dent - Medium / Front Windshield - Damaged - Large</p>

<p>Inspector Notes</p>
<p>Damaged front windshield. Without warranty booklet, jack and tools. With spare tire. 1 key. One LTO plate. One lost plate.</p>
