## General Information

Make	Mitsubishi	Model	Xpander
YOM	2019	Odo Meter Reading	48,057
Registration No.	NDJ9514	Chassis No.	MK2XRNC1WKN042175
CC	1.5	Transmission	A/T
Fuel Type	Gas	Type of Body	Utility Vehicle
Colour	Silver

## Body / Panel Condition

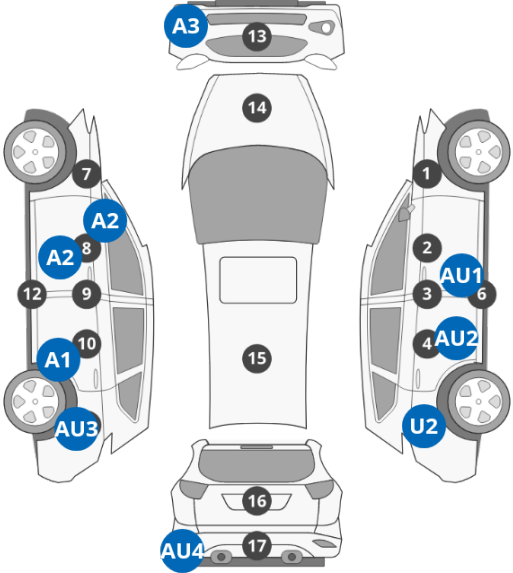
<p><b>A</b> : Scratch <b>AU</b> : Scratch &amp; Dent <b>B</b> : Modified <b>C</b> : Corrosion <b>G</b> : Stone chip <b>P</b> : Faded <b>S</b> : Rust <b>SC</b> : Rust &amp; Corrosion <b>U</b> : Dent <b>X</b> : Defective <b>Y</b> : Crack, Gap</p>
<p><b>Remarks</b> Sunvisor, Sunglass Holder - Crinkle - Small / Ceiling - Grime - Small / (R) Front Floor Mat - Grime - Small / Dashboard - Repair Mark - Yes / Mat Other - Grime - Medium / (L) Front Floor Mat - Worked - Small</p>	<p><b>Remarks</b> (L) Mirror - Scratch - Small / (L) Rear Fender, Molding - Scratch &amp; Dent - Medium / Rear Bumper, Lamps, Panels - Scratch &amp; Dent - Large / (L) Front Door, Molding - Scratch - Small / (L) Rear Door, Molding - Scratch - Minimal / (R) Front Door, Molding - Scratch &amp; Dent - Minimal / (R) Rear Door, Molding - Scratch &amp; Dent - Small / (R) Rear Fender, Molding - Dent - Small / Front Bumper, Grille, Lamps - Scratch - Medium</p>
