General Information

Date & Time: 11, Aug, 2025 14:45

Make	Toyota	Model	Wigo
YOM	2019	Odo Meter Reading	90,355
Registration No.	NBE5545	Chassis No.	MHKA4DF5FJJ022956
CC	1.0	Transmission	A/T
Fuel Type	Gas	Type of Body	Hatchback
Colour	Orange

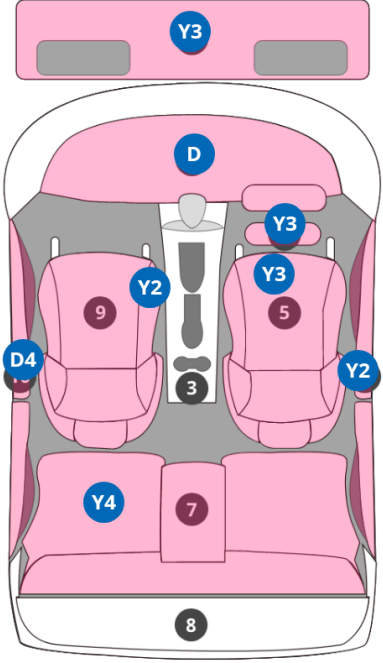
Interior Evaluation : C	Exterior Evaluation : E

<p>A : Scratch AU : Scratch & Dent B : Modified C : Corrosion G : Stone chip P : Faded S : Rust SC : Rust & Corrosion U : Dent X : Defective Y : Crack, Gap</p>
<p>Remarks Ceiling - Grime - Medium / (R) Front Trim - Grime - Small / (R) Front Seat - Grime - Medium / Rear Seat - Grime - Large / Mat Other - Grime - Medium / (L) Front Trim - Worked - Large / (L) Front Seat - Grime - Small / Dashboard - Traces of Adhesive Tape - Yes</p>	<p>Remarks (L) Front Door - Repair Traces - Yes / (L) Step - Repair Traces - Yes / Trunk Hood, Rear Gate - Repair Traces - Yes / (L) Rear Door, Molding - Scratch & Dent - Large / (L) Front Door, Molding - Scratch & Dent - Large / (L) Step, In-panel, Side Spoiler - Scratch & Dent - Small / (L) Front Fender, Molding - Scratch - Small / (L) Mirror - Scratch - Small / (R) Front Fender, Molding - Scratch - Small / Front Bumper, Grille, Lamps - Scratch & Dent - Large / (R) Mirror - Scratch - Small / (R) Front Door, Molding - Scratch - Small / (R) Rear Door, Molding - Scratch - Small / (R) Step, In-panel, Side Spoiler - Scratch & Dent - Small / (R) Rear Fender, Molding - Scratch - Medium / Trunk Hood, Rear Gate - Scratch - Small / Rear Bumper, Lamps, Panels - Scratch & Dent - Medium / Roof - Dent - Small</p>
