## General Information

<b>Make</b>	Toyota	<b>Model</b>	Vios
<b>YOM</b>	2024	<b>Odo Meter Reading</b>	15,909
<b>Registration No.</b>	CBI9993	<b>Chassis No.</b>	PA1B18F34P4226846
<b>CC</b>	1.3	<b>Transmission</b>	CVT
<b>Fuel Type</b>	Gas	<b>Type of Body</b>	Sedan
<b>Colour</b>	Blackish Red Mica

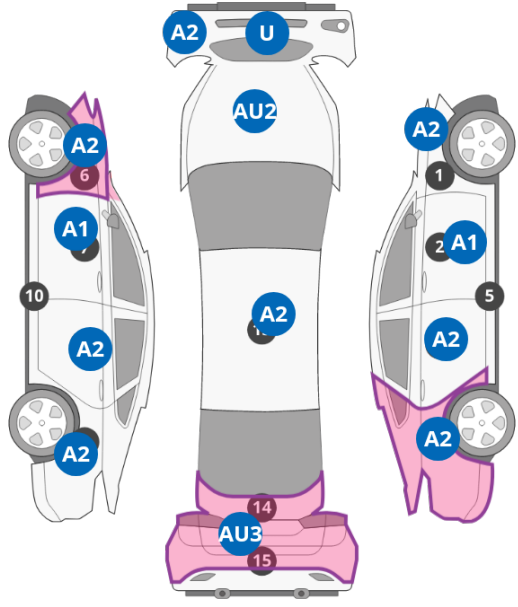
<p><b>A</b> : Scratch <b>AU</b> : Scratch &amp; Dent <b>B</b> : Modified <b>C</b> : Corrosion <b>G</b> : Stone chip <b>P</b> : Faded <b>S</b> : Rust <b>SC</b> : Rust &amp; Corrosion <b>U</b> : Dent <b>X</b> : Defective <b>Y</b> : Crack, Gap</p>
<p><b>Remarks</b> (L) Front Floor Mat - Worked - Small / (L) Front Trim - Worked - Small / (R) Front Trim - Worked - Small / Ceiling - Grime - Minimal</p>	<p><b>Remarks</b> (L) Front Fender - Repair Traces - Yes / Trunk Hood, Rear Gate - Repair Traces - Yes / (R) Rear Fender - Repair Traces - Yes / (R) Rear Fender - Replaced - Yes / (R) Rear Fender, Molding - Repair mark - Yes / Trunk Hood, Rear Gate - Repair mark - Yes / (L) Front Fender, Molding - Repair mark - Yes / Trunk Hood, Rear Gate - Scratch &amp; Dent - Medium / (L) Rear Fender, Molding - Scratch - Small / (L) Rear Door, Molding - Scratch - Small / (L) Front Door, Molding - Scratch - Minimal / Member (Bolted) - Dent - Yes / Front Bumper, Grille, Lamps - Scratch - Small / (R) Front Fender, Molding - Scratch - Small / (R) Front Door, Molding - Scratch - Minimal / (R) Rear Door, Molding - Scratch - Small / (R) Rear Fender, Molding - Scratch - Small / Bonnet, Headlight - Scratch &amp; Dent - Small / Roof - Scratch - Small / (L) Front Fender, Molding - Scratch - Small</p>
