General Information

Make	Toyota	Model	Veloz
YOM	2023	Odo Meter Reading	10,373
Registration No.	NKG4188	Chassis No.	MHFAB1BY2N3039657
CC	1.5	Transmission	CVT
Fuel Type	Gas	Type of Body	SUV
Colour	White

Body / Panel Condition

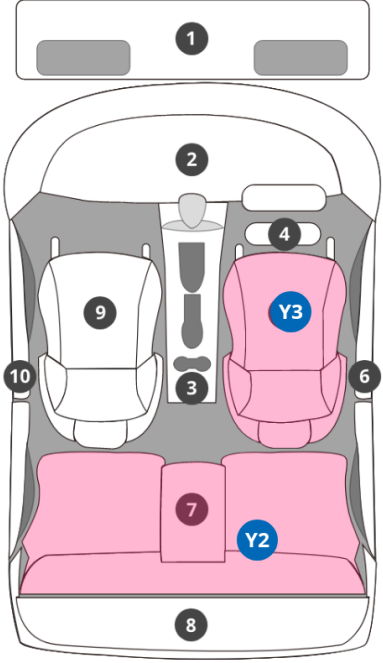
Interior Evaluation : B	Exterior Evaluation : E

<p>A : Scratch AU : Scratch & Dent B : Modified C : Corrosion G : Stone chip P : Faded S : Rust SC : Rust & Corrosion U : Dent X : Defective Y : Crack, Gap</p>
<p>Remarks Rear Seat - Grime - Small / (R) Front Seat - Grime - Medium</p>	<p>Remarks Bonnet - Repair Traces - Yes / Rear Bumper, Lamps, Panels - Scratch - Medium / (R) Rear Fender, Molding - Partially Missing - Yes / (R) Rear Fender, Molding - Scratch & Dent - Small / (R) Rear Door, Molding - Scratch & Dent - Large / (R) Front Door, Molding - Scratch - Small / (R) Mirror - Scratch - Minimal / Front Bumper, Grille, Lamps - Repair mark - Yes / Front Bumper, Grille, Lamps - Scratch - Small / Bonnet, Headlight - Repair mark - Yes / (L) Mirror - Scratch - Minimal / (L) Step, In-panel, Side Spoiler - Scratch - Minimal / (L) Front Door, Molding - Scratch - Small / (L) Rear Door, Molding - Scratch & Dent - Medium / Trunk Hood, Rear Gate - Scratch - Minimal / (L) Rear Fender, Molding - Scratch - Minimal / (L) Side Window - Damaged - Large</p>
