## General Information

<b>Make</b>	Toyota	<b>Model</b>	Vios
<b>YOM</b>	2024	<b>Odo Meter Reading</b>	38,985
<b>Registration No.</b>	DBF8770	<b>Chassis No.</b>	PA1B18F38R4254541
<b>CC</b>	1.3	<b>Transmission</b>	CVT
<b>Fuel Type</b>	Gas	<b>Type of Body</b>	Sedan
<b>Colour</b>	Red Mica Metallic

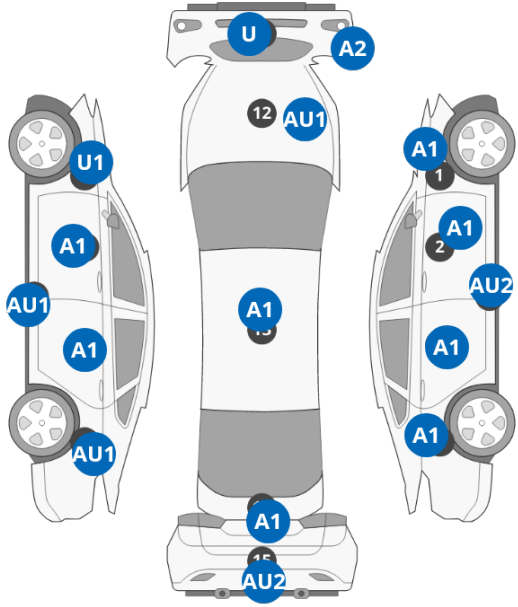
<p><b>A</b> : Scratch <b>AU</b> : Scratch &amp; Dent <b>B</b> : Modified <b>C</b> : Corrosion <b>G</b> : Stone chip <b>P</b> : Faded <b>S</b> : Rust <b>SC</b> : Rust &amp; Corrosion <b>U</b> : Dent <b>X</b> : Defective <b>Y</b> : Crack, Gap</p>
<b>Remarks</b> Defects not found	<b>Remarks</b> (L) Front Fender, Molding - Dent - Minimal / (L) Front Door, Molding - Scratch - Minimal / (L) Rear Door, Molding - Scratch - Minimal / (L) Rear Fender, Molding - Scratch & Dent - Minimal / (L) Step, In-panel, Side Spoiler - Scratch & Dent - Minimal / Member (Bolted) - Dent - Yes / Front Bumper, Grille, Lamps - Scratch - Small / (R) Front Fender, Molding - Scratch - Minimal / (R) Front Door, Molding - Scratch - Minimal / (R) Rear Door, Molding - Scratch - Minimal / (R) Step, In-panel, Side Spoiler - Scratch & Dent - Small / (R) Rear Fender, Molding - Scratch - Minimal / Rear Bumper, Lamps, Panels - Scratch & Dent - Small / Trunk Hood, Rear Gate - Scratch - Minimal / Bonnet, Headlight - Scratch & Dent - Minimal / Roof - Scratch - Minimal

with LTO plate and Sparetire and Jack, Incomplete Tools. No warranty booklet and scratch headlight and tail light.
