## General Information

Date & Time: 19, Aug, 2025 10:08

<b>Make</b>	Toyota	<b>Model</b>	Avanza
<b>YOM</b>	2024	<b>Odo Meter Reading</b>	25,132
<b>Registration No.</b>	NHM5437	<b>Chassis No.</b>	MHFAA1BY5P0021905
<b>CC</b>	1.3	<b>Transmission</b>	CVT
<b>Fuel Type</b>	Gas	<b>Type of Body</b>	MPV
<b>Colour</b>	Green

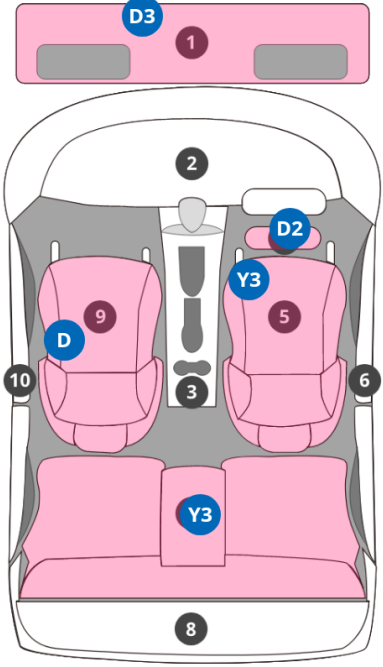
<p><b>a</b> : Cut, Fray <b>d</b> : Loose, Deformed <b>k</b> : Animal Hair <b>s</b> : Smell <b>t</b> : Cigarette Burns <b>x</b> : Defective <b>y</b> : Stain</p>

<p><b>A</b> : Scratch <b>AU</b> : Scratch &amp; Dent <b>B</b> : Modified <b>C</b> : Corrosion <b>G</b> : Stone chip <b>P</b> : Faded <b>S</b> : Rust <b>SC</b> : Rust &amp; Corrosion <b>U</b> : Dent <b>X</b> : Defective <b>Y</b> : Crack, Gap</p>
<b>Remarks</b> (R) Front Seat - Grime - Medium / (L) Front Seat - Worn - Yes / Rear Seat - Grime - Medium / (L) Front Floor Mat - Worked - Small / Ceiling - Crinkle - Medium	<b>Remarks</b> (L) Front Door - Repair Traces - Yes / (L) Rear Door - Repair Traces - Yes / (R) Front Fender, Molding - Dent - Medium / (R) Front Door, Molding - Scratch & Dent - Large / (R) Rear Door, Molding - Scratch - Small / (R) Rear Fender, Molding - Dent - Minimal / Rear Bumper, Lamps, Panels - Scratch - Small / Trunk Hood, Rear Gate - Scratch - Small / (L) Rear Fender, Molding - Scratch & Dent - Small / (L) Front Door, Molding - Scratch & Dent - Minimal / (L) Rear Door, Molding - Scratch - Minimal / (L) Front Fender, Molding - Scratch - Minimal / Front Bumper, Grille, Lamps - Repair mark - Yes / Front Bumper, Grille, Lamps - Scratch - Medium / Bonnet, Headlight - Scratch - Minimal / Roof - Scratch - Minimal
