## General Information

<b>Make</b>	Toyota	<b>Model</b>	Avanza
<b>YOM</b>	2025	<b>Odo Meter Reading</b>	7,948
<b>Registration No.</b>	NHU6999	<b>Chassis No.</b>	MHFAA1BY5R0030431
<b>CC</b>	1.3	<b>Transmission</b>	CVT
<b>Fuel Type</b>	Gas	<b>Type of Body</b>	MPV
<b>Colour</b>	Black

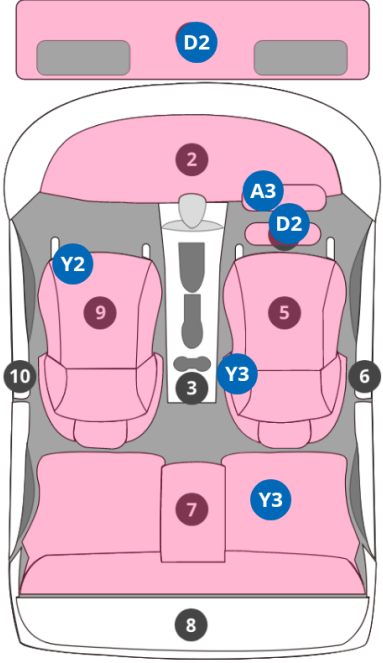
<b>Interior Evaluation :</b> <span style="float: right; color: red; font-weight: bold;">B</span>	<b>Exterior Evaluation :</b> <span style="float: right; color: red; font-weight: bold;">D</span>

<p><b>a</b> : Cut, Fray <b>d</b> : Loose, Deformed <b>k</b> : Animal Hair <b>s</b> : Smell <b>t</b> : Cigarette Burns <b>x</b> : Defective <b>y</b> : Stain</p>

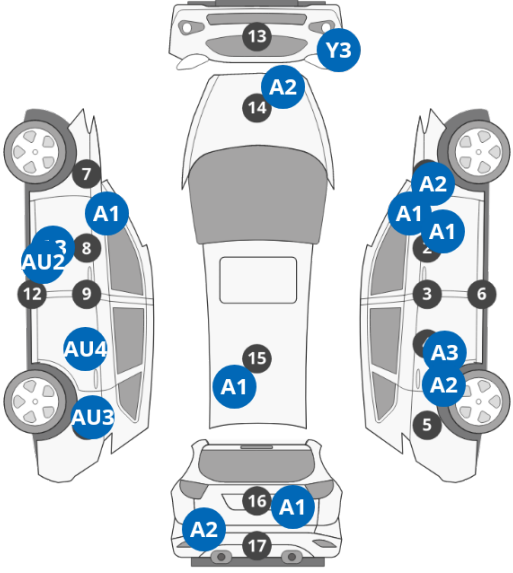
<p><b>A</b> : Scratch <b>AU</b> : Scratch &amp; Dent <b>B</b> : Modified <b>C</b> : Corrosion <b>G</b> : Stone chip <b>P</b> : Faded <b>S</b> : Rust <b>SC</b> : Rust &amp; Corrosion <b>U</b> : Dent <b>X</b> : Defective <b>Y</b> : Crack, Gap</p>
<p><b>Remarks</b> (L) Front Seat - Grime - Small / (L) Front Floor Mat - Worked - Small / (R) Front Seat - Grime - Medium / Rear Seat - Grime - Medium / Glove Box - Worn, Scratch, Cut, Crack - Medium / Ceiling - Crinkle - Small</p>	<p><b>Remarks</b> (R) Front Fender, Molding - Scratch - Small / (R) Mirror - Scratch - Minimal / (R) Rear Door, Molding - Scratch - Medium / (R) Rear Fender, Molding - Scratch - Small / Trunk Hood, Rear Gate - Scratch - Minimal / (L) Rear Fender, Molding - Scratch &amp; Dent - Medium / (L) Rear Door, Molding - Scratch &amp; Dent - Large / (L) Front Door, Molding - Scratch - Medium / (L) Step, In-panel, Side Spoiler - Scratch &amp; Dent - Small / (L) Mirror - Scratch - Minimal / Front Bumper, Grille, Lamps - Crack, Gap - Medium / Bonnet, Headlight - Scratch - Small / (R) Front Door, Molding - Scratch - Minimal / Rear Bumper, Lamps, Panels - Scratch - Small / Roof - Scratch - Minimal</p>
